The Dover/Kent County Metropolitan Planning Organization

Delaware State University Pedestrian Counts

SUMMARY REPORT December 2014

Century Engineering, Inc.
4134 N. DuPont Highway, Dover, DE 19901

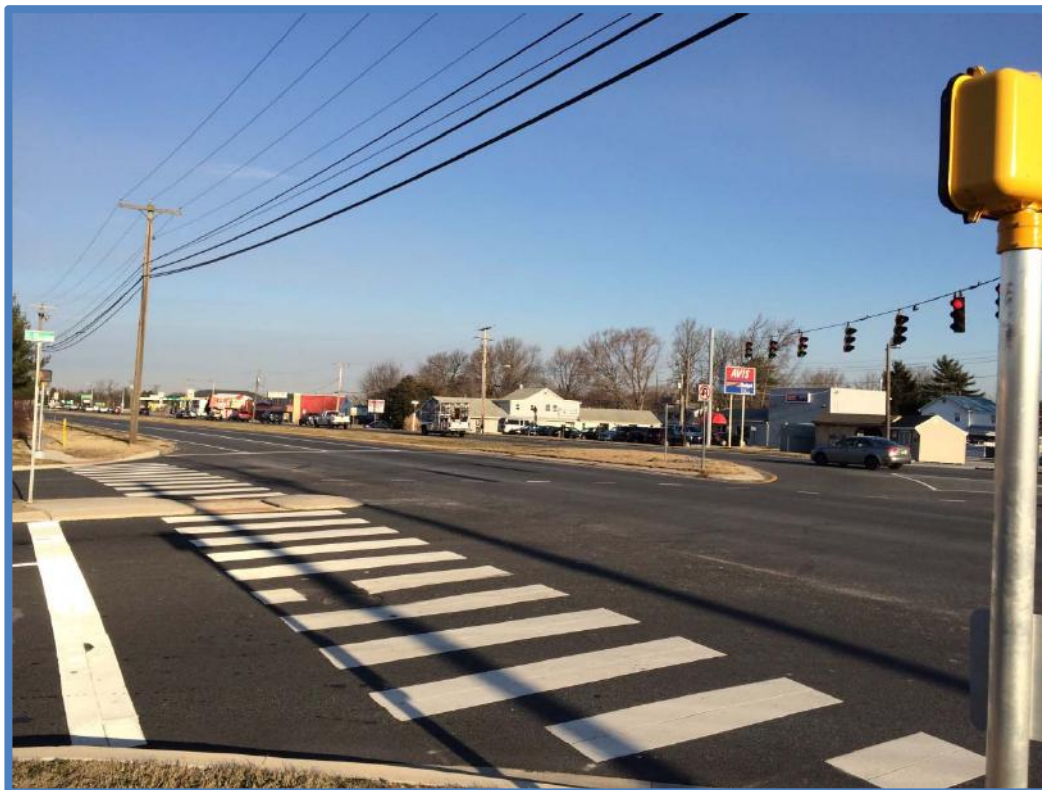
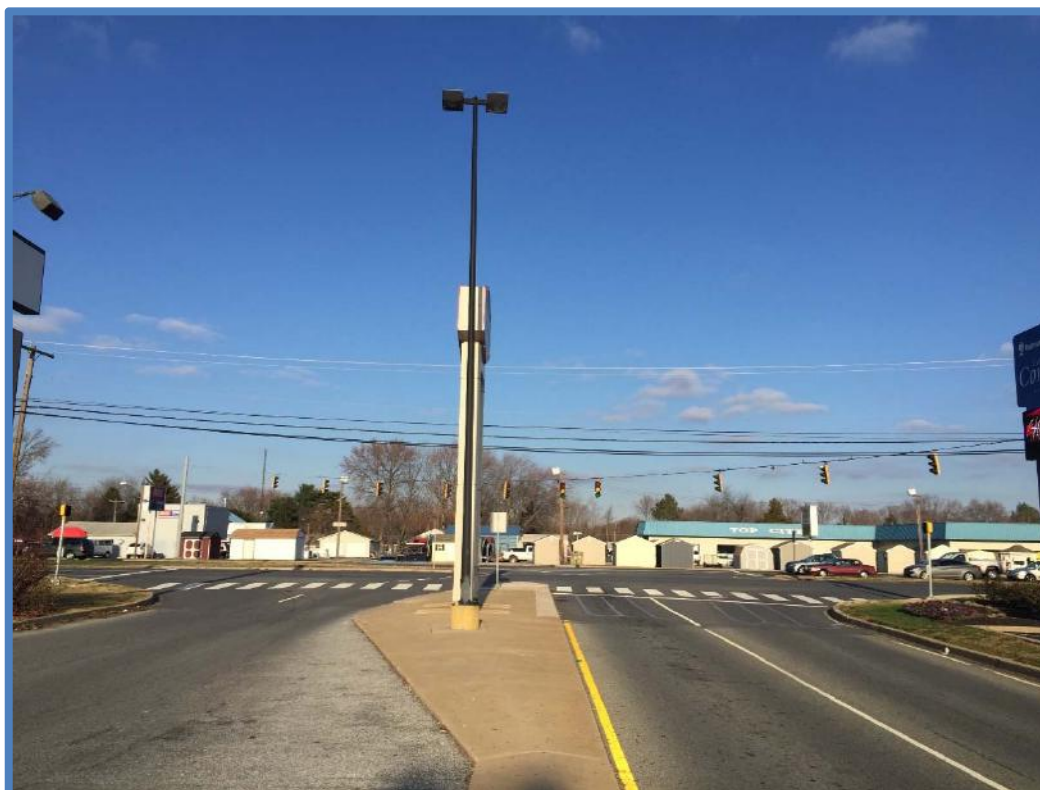
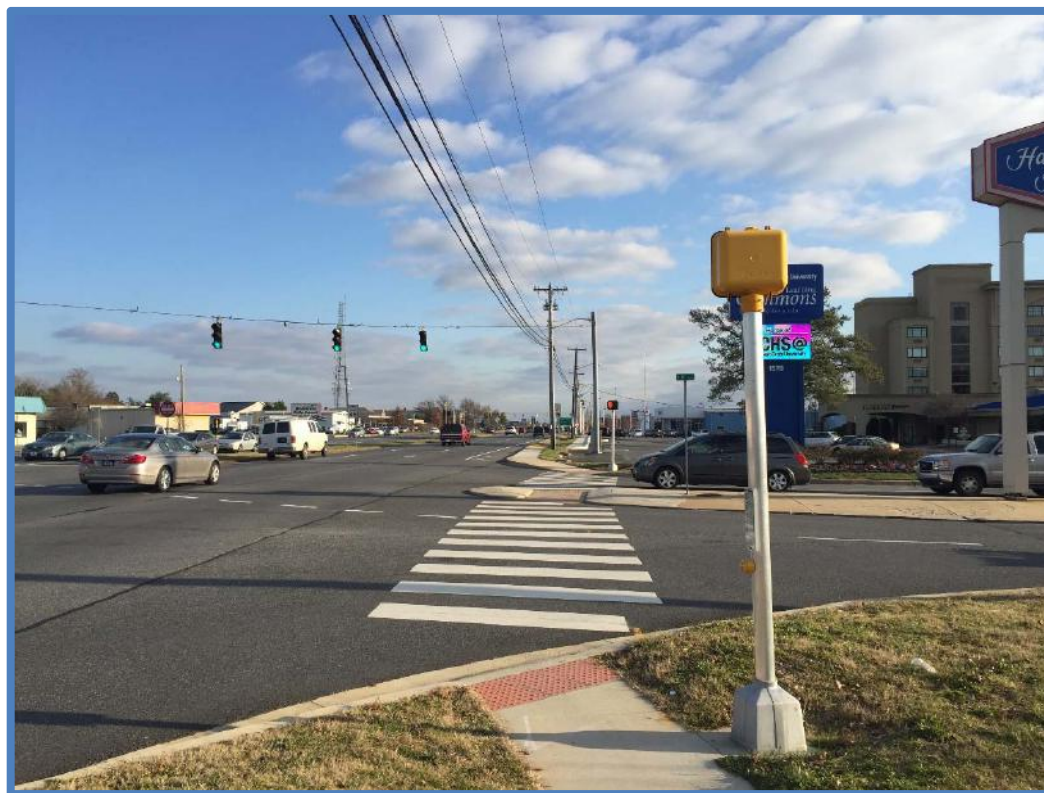
LOCATION 1 – DSU COMMONS ENTRANCE (SHERATON)

Summary: There was very little crossing activity at this location primarily due to the destinations being south of the intersection. There were some midblock crossings on the north side of the intersection particularly on the weekday mornings. This was consistent with the 2013 counts. A sidewalk along the frontage of US 13 was installed in the spring of 2014 and pedestrians were observed using this sidewalk. This appeared to help better direct the users but many still went across the Common's parking lot to get to the entrance. The overall pedestrian patterns were similar to that of the previous counts.

Concerns: Pedestrians were cutting across the parking lot to get to the Commons's entrance.

DSU Commons entrance looking north on US13

DSU Commons entrance looking east towards US13

DSU Commons entrance looking south on US13

Recommendation: An additional option is to explore the opportunity to provide a trail connection to DSU's campus west of US 13 behind the frontage properties. This would reduce the need to walk/ride along US 13.

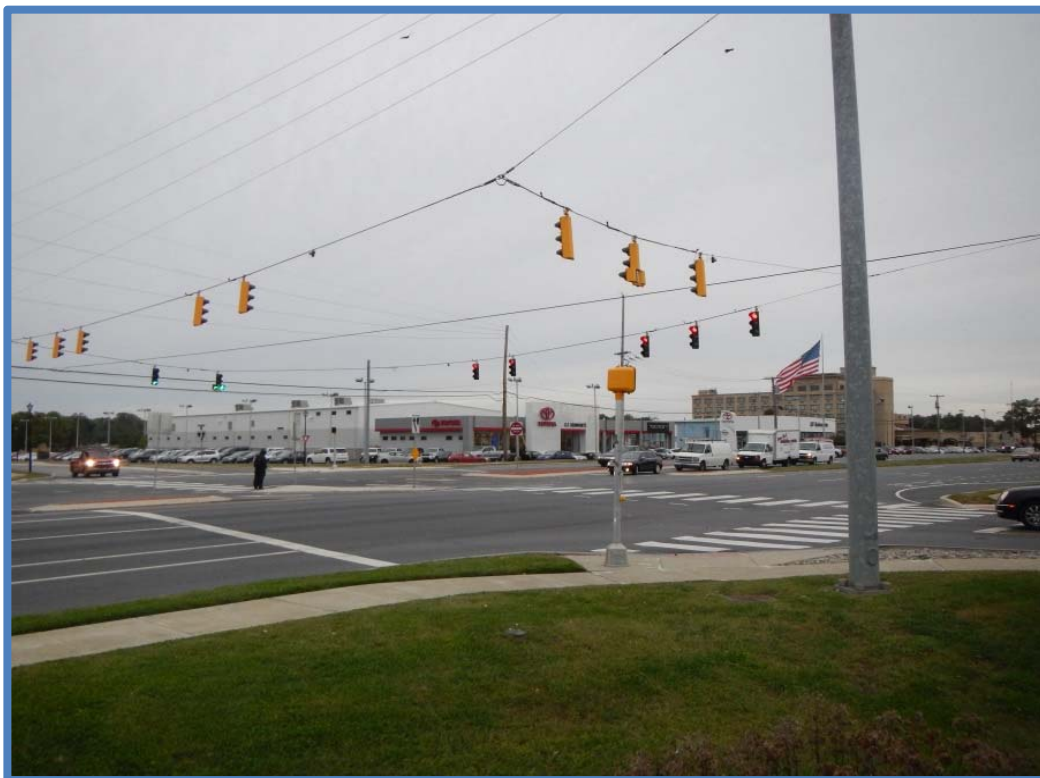
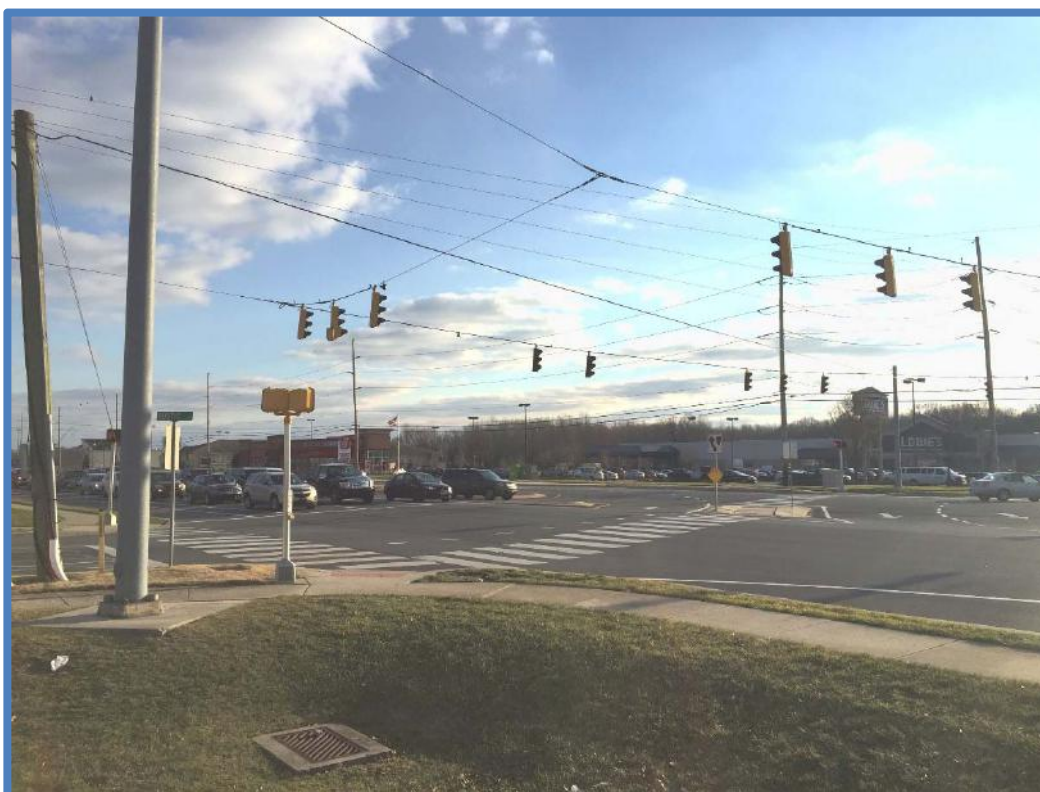
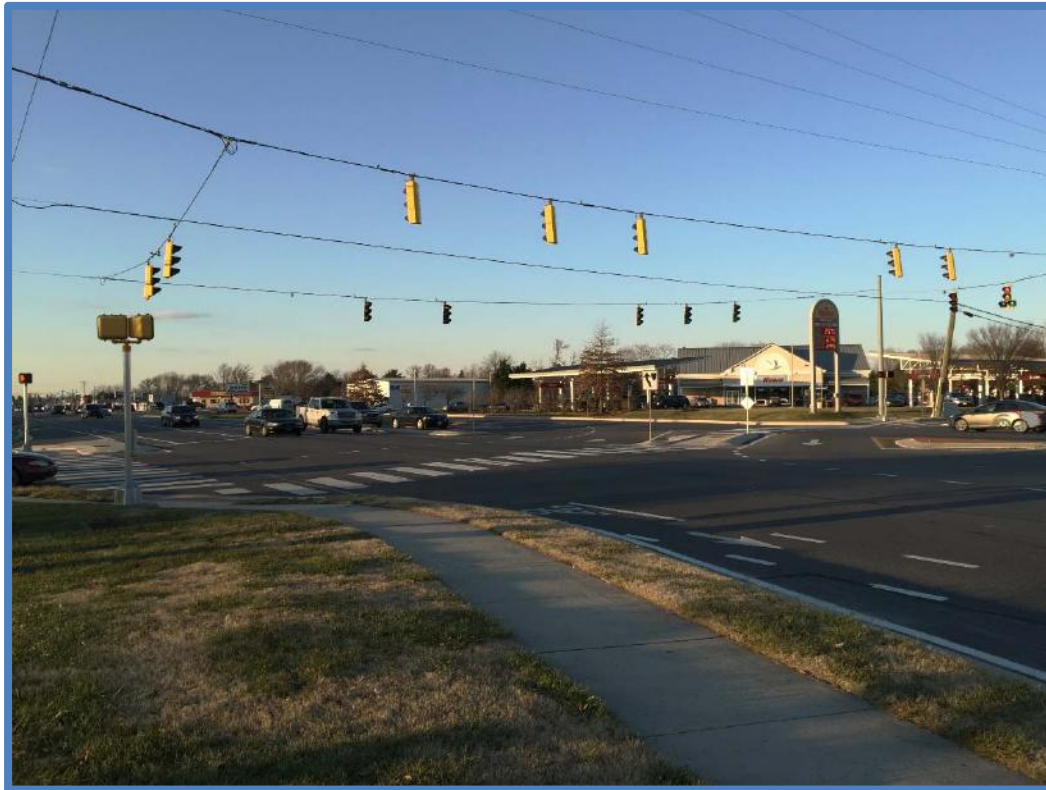
LOCATION 2 – RUSTIC LANE

Summary: This location had consistent pedestrian traffic with two main movements: crossing US 13 to go to the Sonic and Wawa, and traveling to/from the Commons and DSU's campus. This intersection has a diagonal crosswalk of US 13 which was used by several people. The majority of the movement was along the western side of US 13 and the pedestrians stayed within the crosswalk. A significant number of people cross north of the intersection to travel between the Commons and the Wawa/Sonic. These movements were consistent with the data from 2013 but the number of mid-block crossings was higher than the prior year.

Concerns: The primary concern was the midblock crossing north of Rustic Lane. The majority of these crossings seemed to be going to/from the Commons where the direct path is to cross before Rustic Lane.

East side of US13 looking northwest towards W. Rustic Ln

East side of US13 looking southwest towards W. Rustic Lane

West side of US13 looking northeast towards Wawa

Recommendation: Continue to educate the residents and users of the Commons facility to cross at designated crossing locations. Signs can also be added to guide pedestrians to the nearest crossing. A post and chain fence could be considered along the auto dealership to reduce the opportunity to cross but utility and clear zones (if not breakaway) will need to be considered.

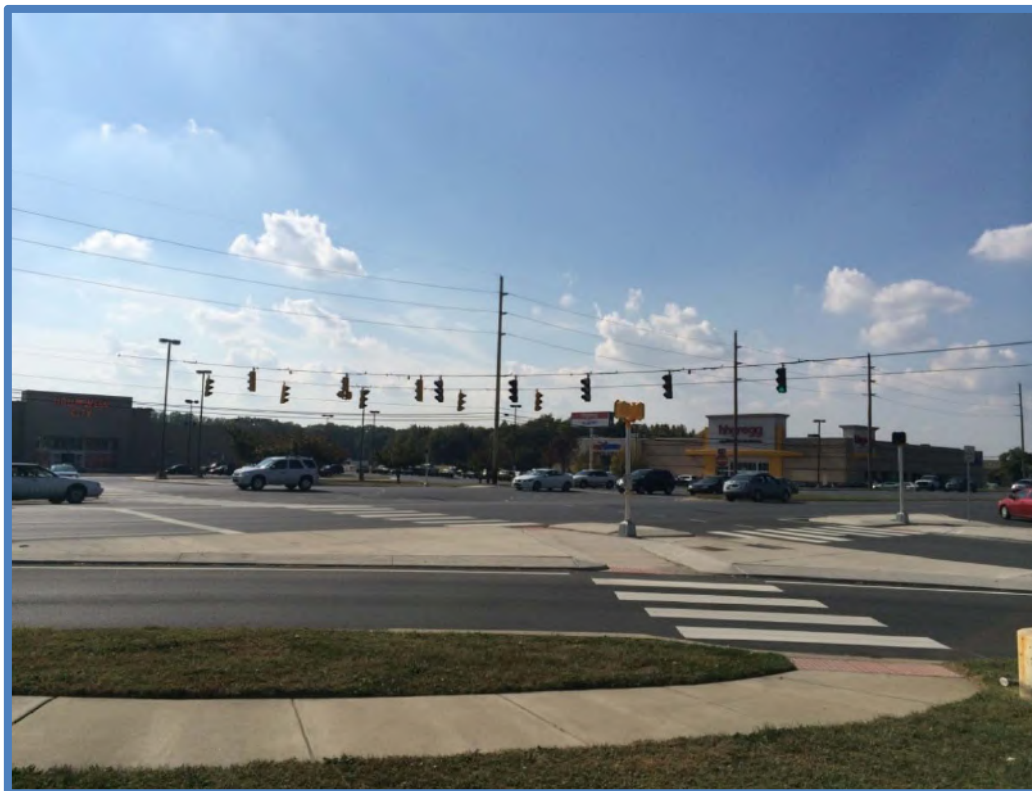
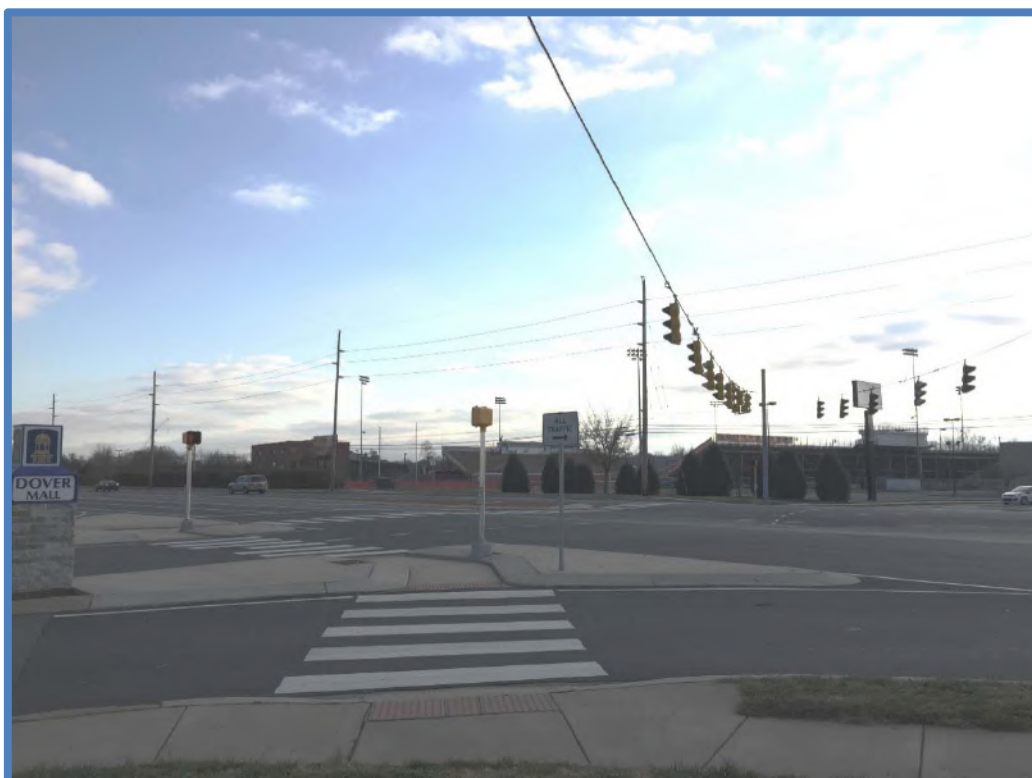
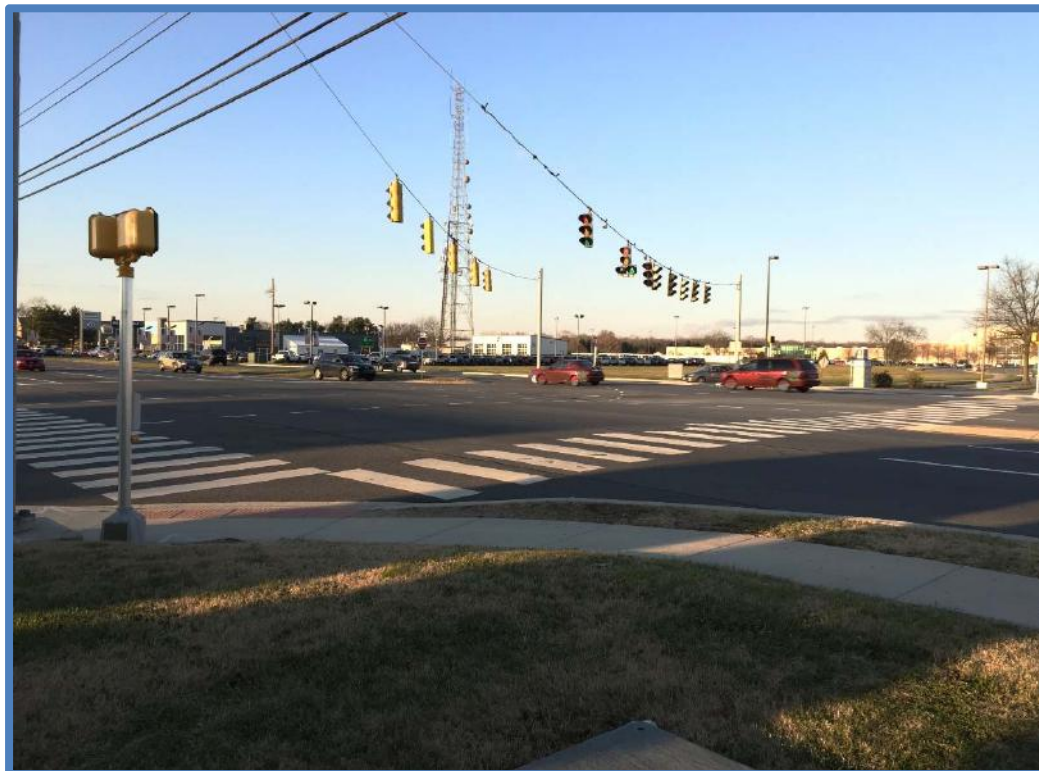
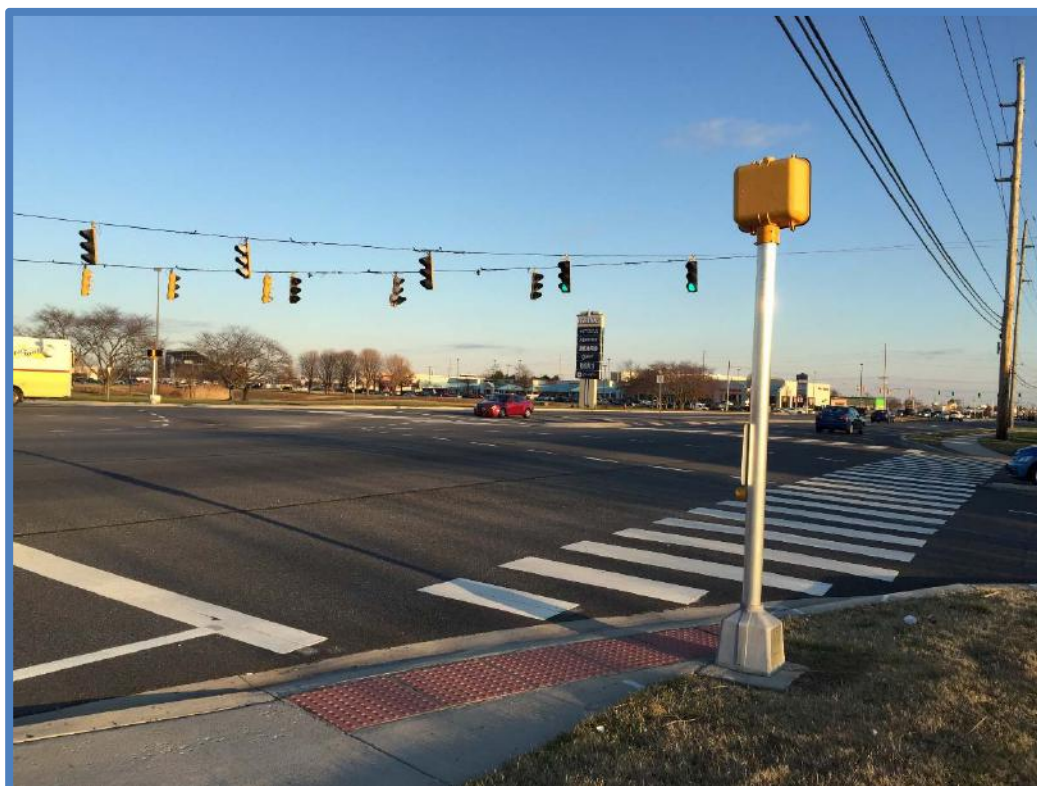
LOCATION 3 – NORTH DOVER MALL ENTRANCE

Summary: This location has some of the lower pedestrian volumes. The western leg had the majority of pedestrian traffic traveling in the north/south direction. Once at the intersection the pedestrians used the crosswalk. There was a sizeable amount of pedestrian traffic crossing in between Rustic Lane and the north Dover Mall Entrance. It appeared that the pedestrians were heading between the State Police and Auto dealership properties. A sidewalk was constructed in 2014 in front of the Capital Inn of Dover (between Lowes and hhgregg) which was being used by pedestrians. The pedestrian movements were similar to that of 2013 but with a higher percentage of people not using the crosswalks in the late afternoon counts (32% - 16%; 22% - 15% for the entire day).

Concerns: The primary concern was the midblock crossing north of the Dover Mall Entrance. It appears that the pedestrians are crossing in the long median between traffic signals to go to the State Police campus.

East side of US13 looking west towards HH Gregg

East side of US13 looking southwest towards DSU

West side of US13 looking northeast towards Dover Mall

West side of US13 looking southeast towards Dover Mall

Recommendation: Install additional sidewalks to make a complete system on the east side of the road so there will be access to the traffic signals on both the north and southbound directions. Consider physical treatments (post and chain fence) to prevent crossings into the median area.

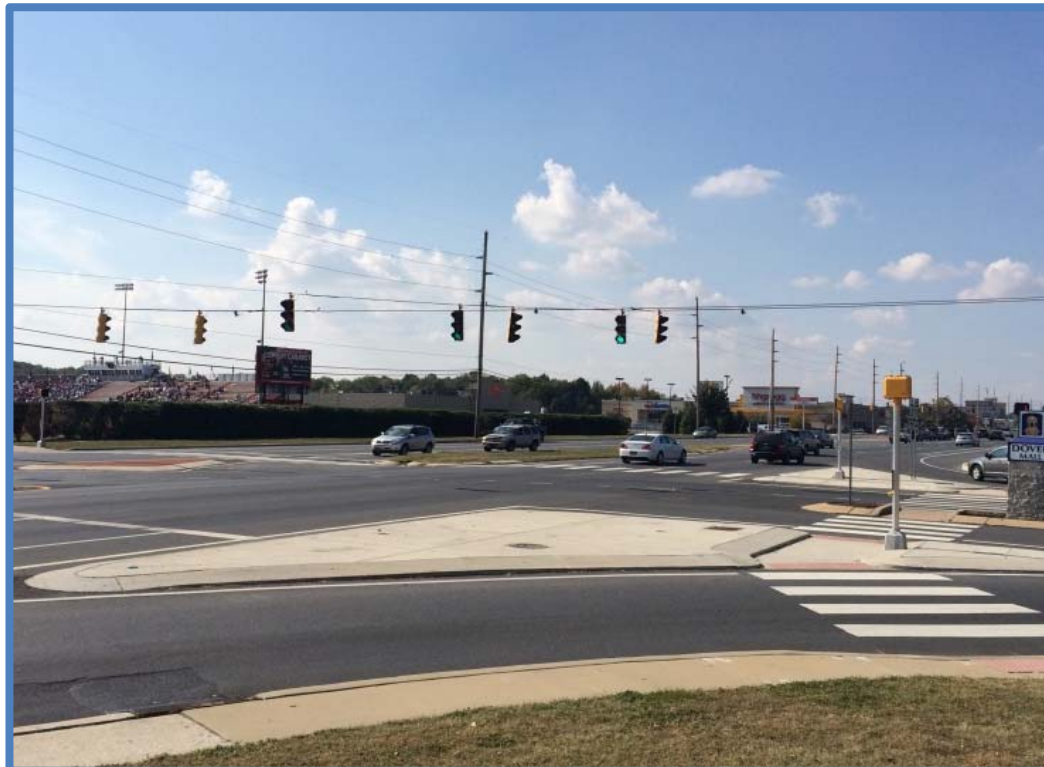
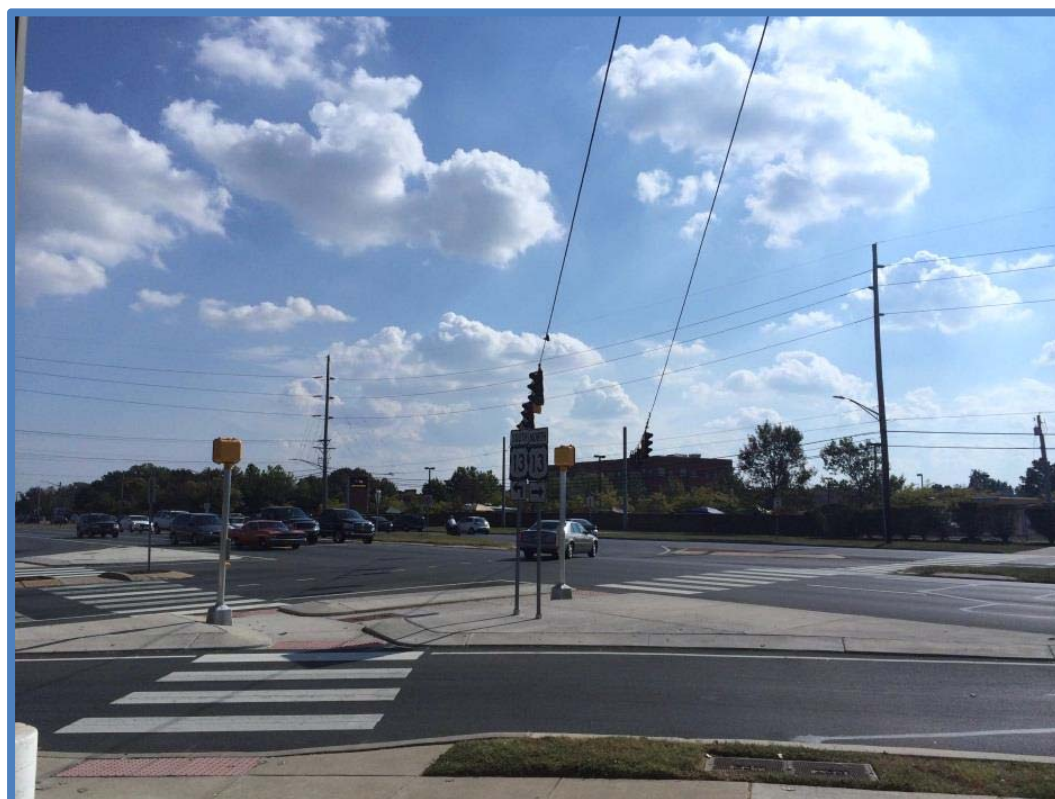
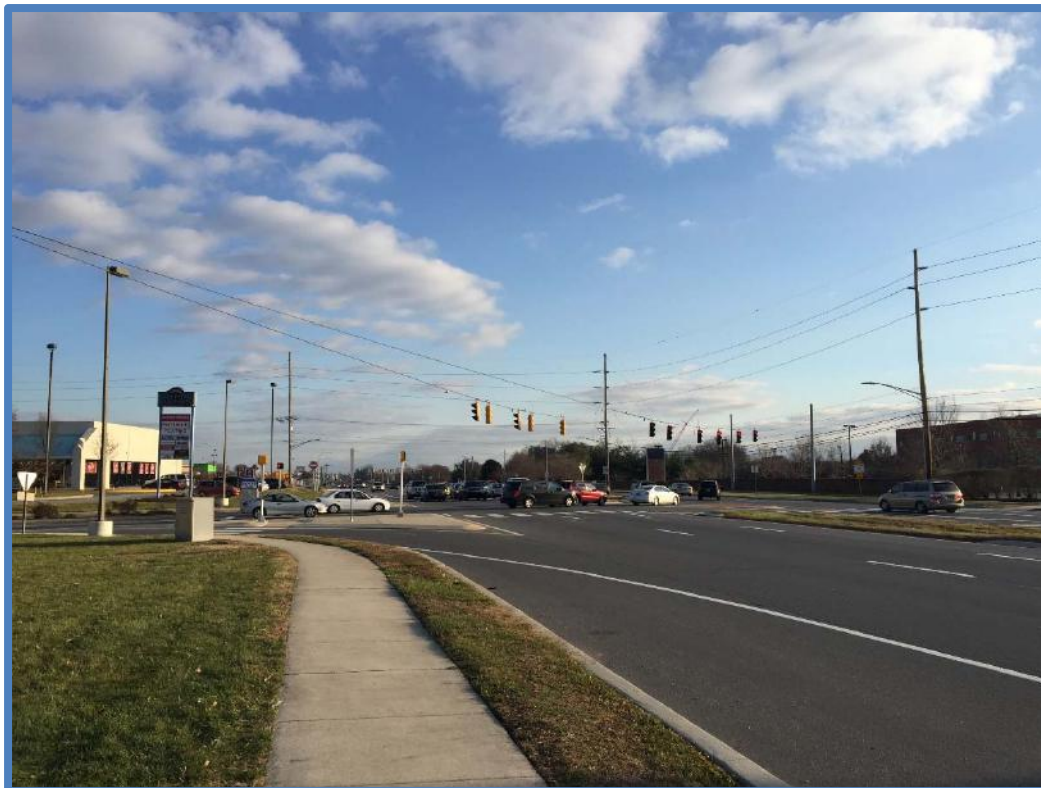
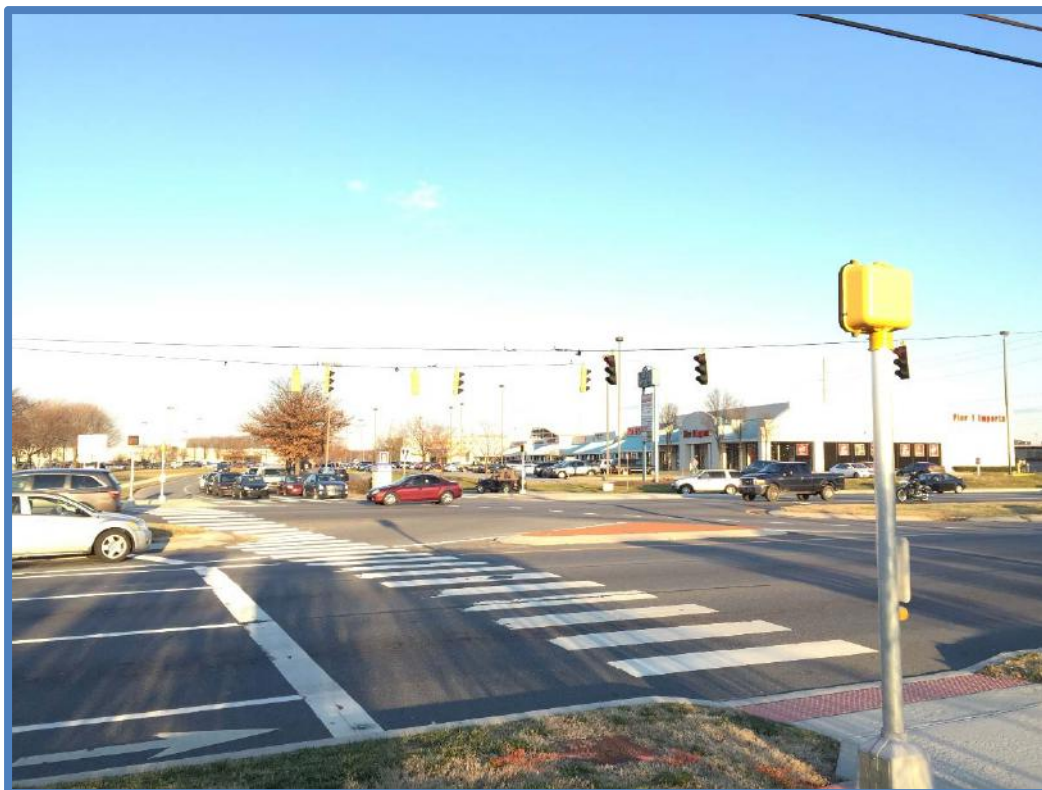
LOCATION 4 – SOUTH DOVER MALL ENTRANCE

Summary: The majority of pedestrians at this location use the designated crosswalks along US 13. This can be attributed to the alignment of the path from DSU's campus and the addition of sidewalks at the Dover Mall. There were numerous pedestrians crossing east of the traffic signal across Mall Road to get to the Dover Commons.

Concerns: A determination should be made if cyclists should be permitted on the sidewalk along the DSU's frontage or if they should be directed to the on-road facilities. People were also observed crossing between cars and outside of the crosswalk along the Mall Road.

East side of US13 looking northwest towards DSU Stadium

East side of US13 looking southwest towards Dover

East side of US13 looking south towards Dover

West side of US13 looking east towards Dover Mall

Recommendation: Place a physical barrier such as landscaping or fencing to prevent people from crossing across Mall Road.

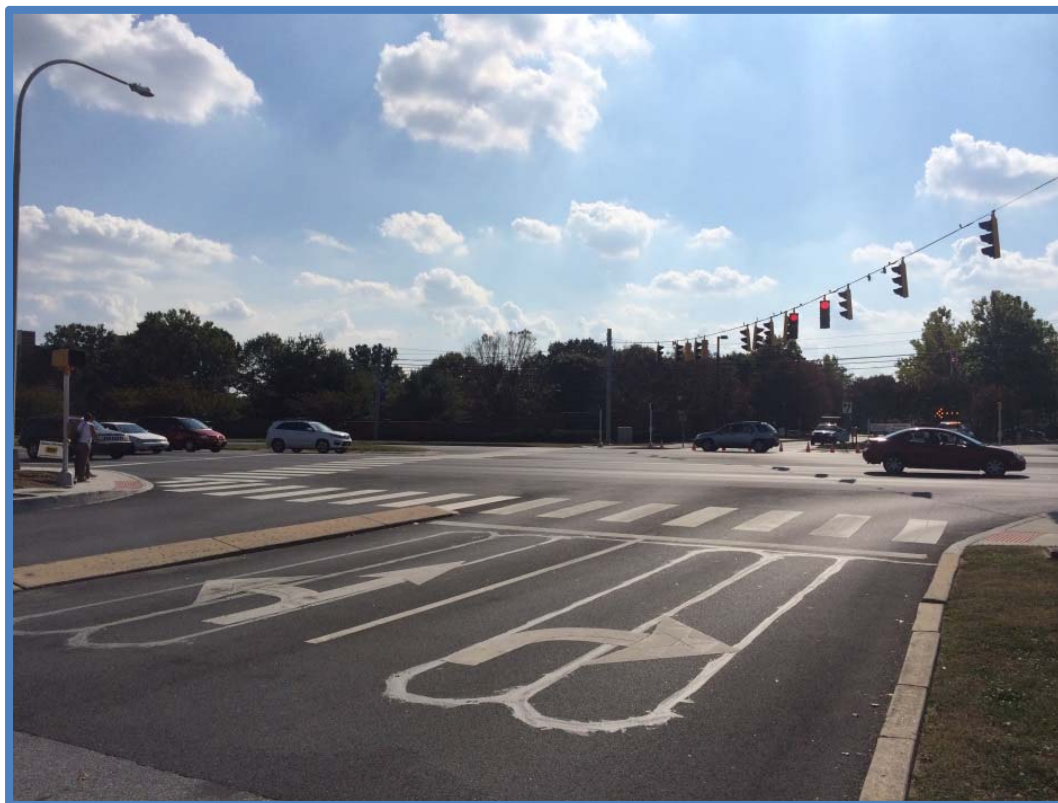
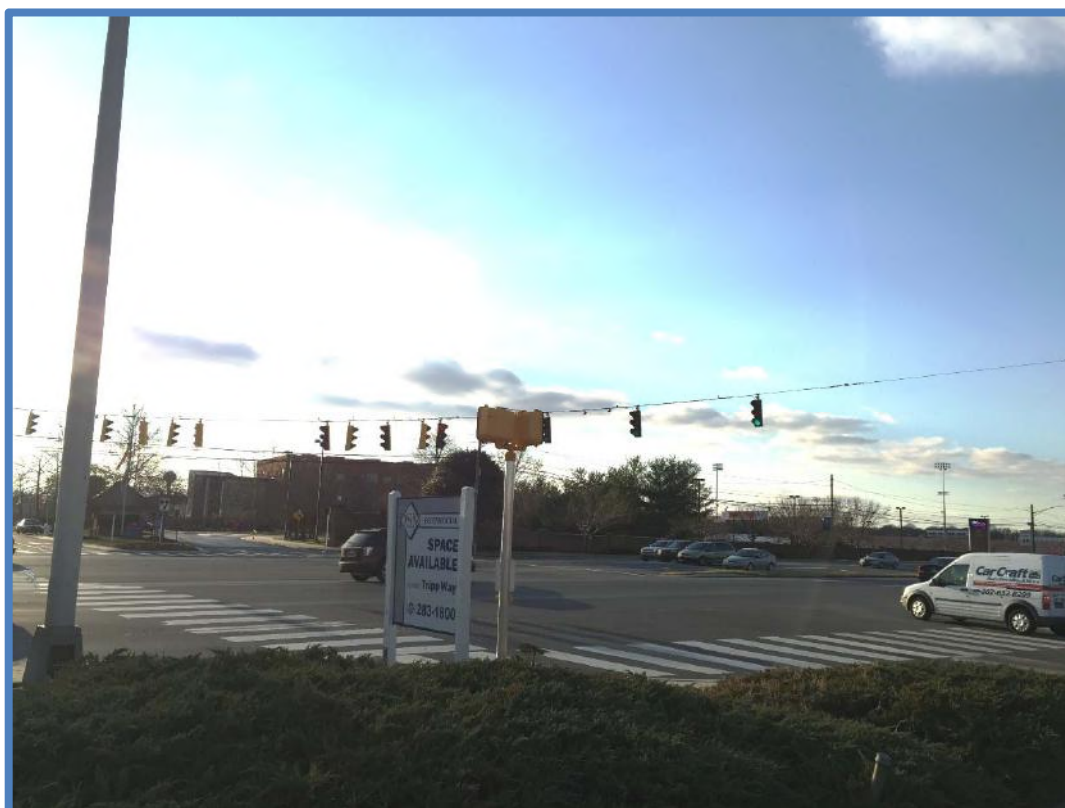
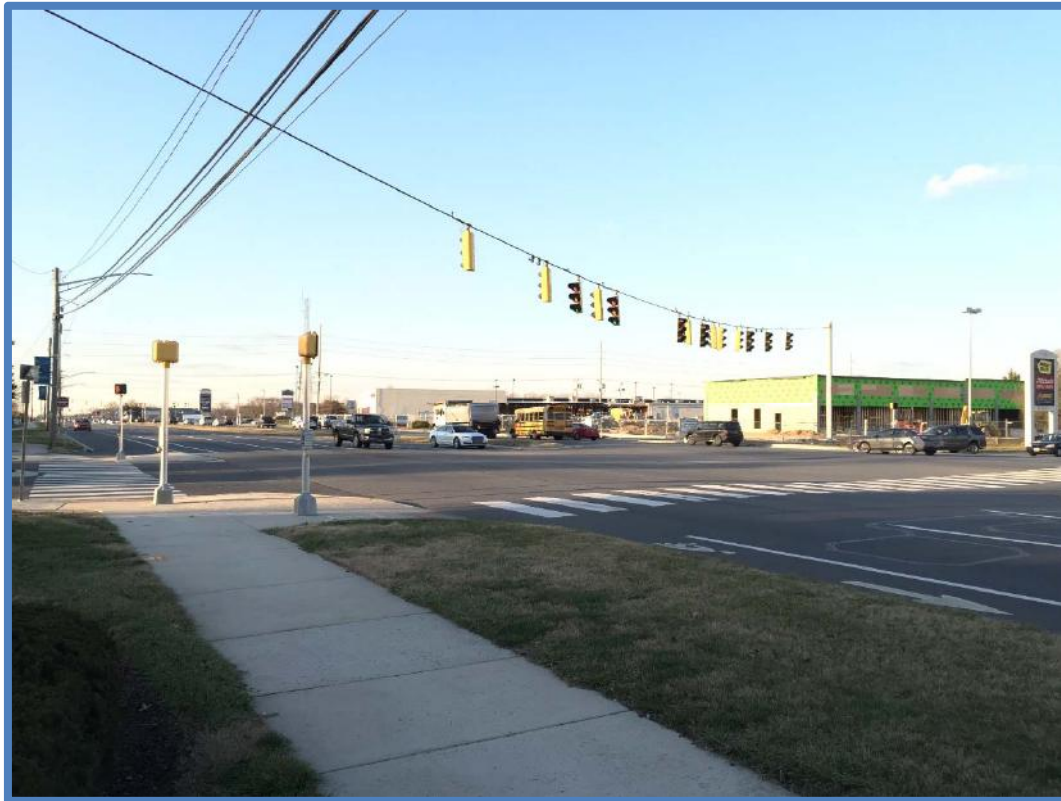
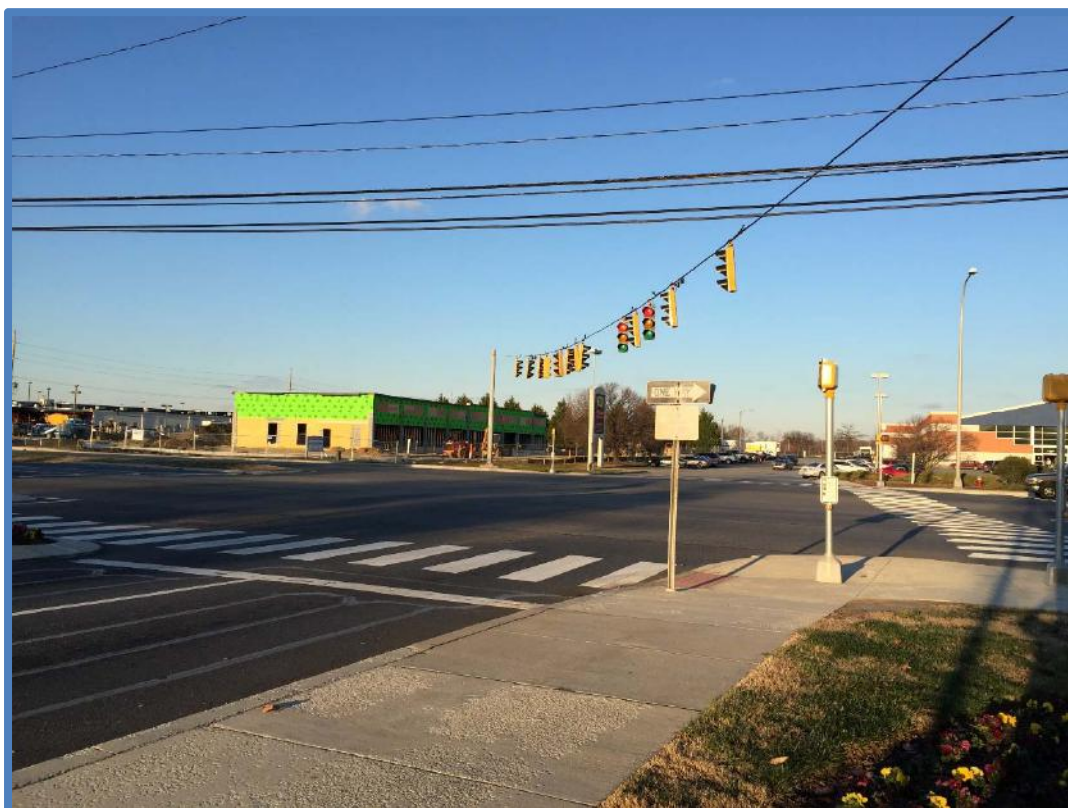
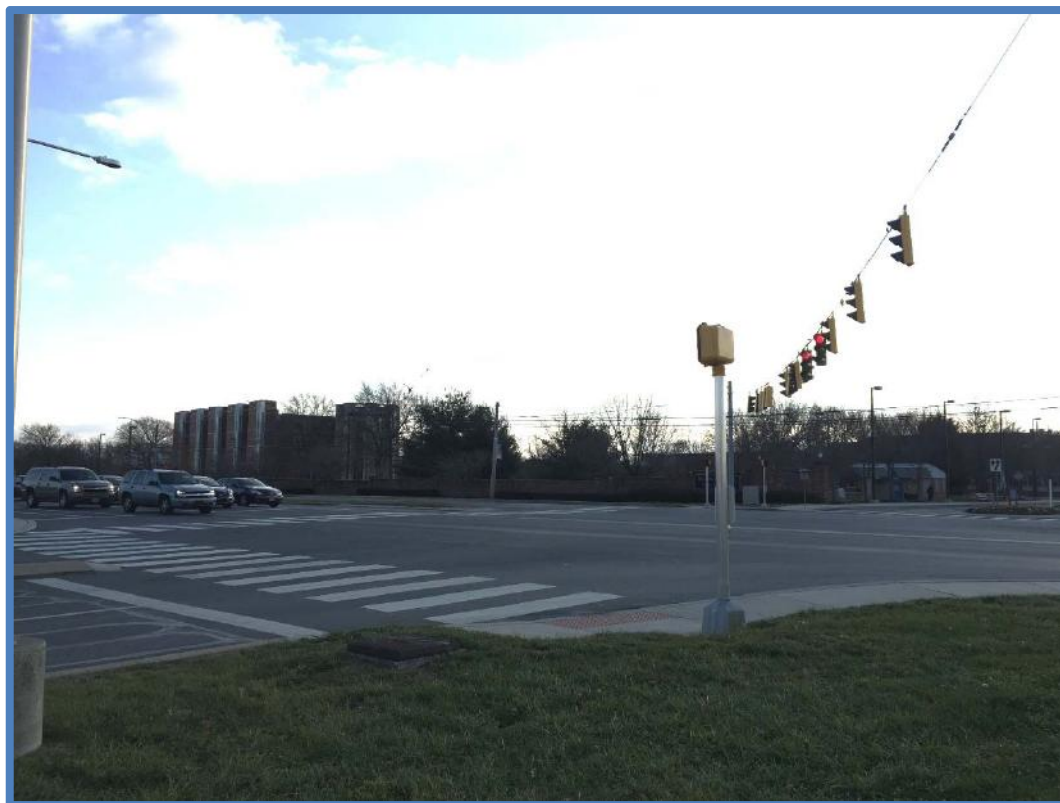
LOCATION 5 – DELAWARE STATE UNIVERSITY ENTRANCE

Summary: This location was one of the busiest during the week but had the most pedestrian activity on the weekend due to people parking at the Dover Mall and walking over to the stadium for homecoming. While the majority of people (over 95%) used the crosswalks there were some that crossed mid-block or on the north side of the intersection where there are no markings. The pedestrian patterns are very similar to those from 2013.

Concerns: The number of people crossing on the north side of the intersection during the week was low. The higher numbers during homecoming were likely skewed due to the number of people crossing at the same time. Some of these people were heading to/from Best Buy and the Dover Mall.

East side of US13 looking west towards DSU

West side of US13 looking northeast towards Dover Mall

West side of US13 looking east towards BestBuy

East side of US13 looking southwest towards DSU

Recommendation: For DSU's football games the entrance is closed and they have a police presence which helps to control traffic and protect pedestrians. This should be continued especially during the larger crowds such as homecoming.

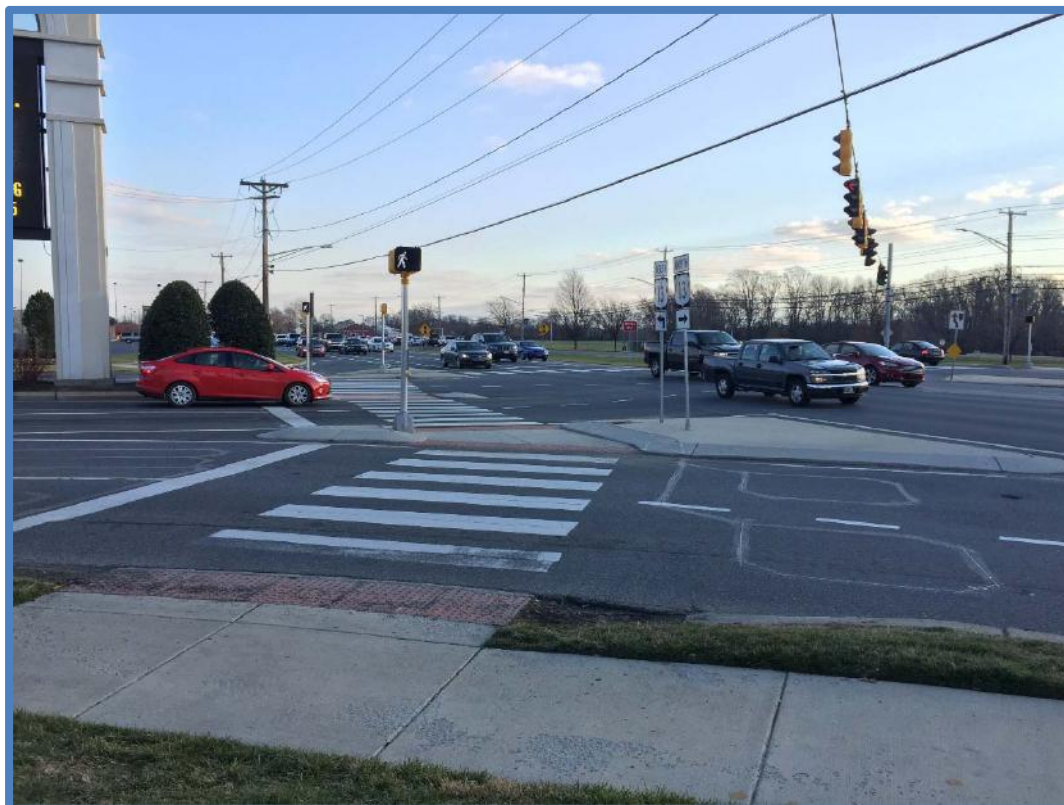
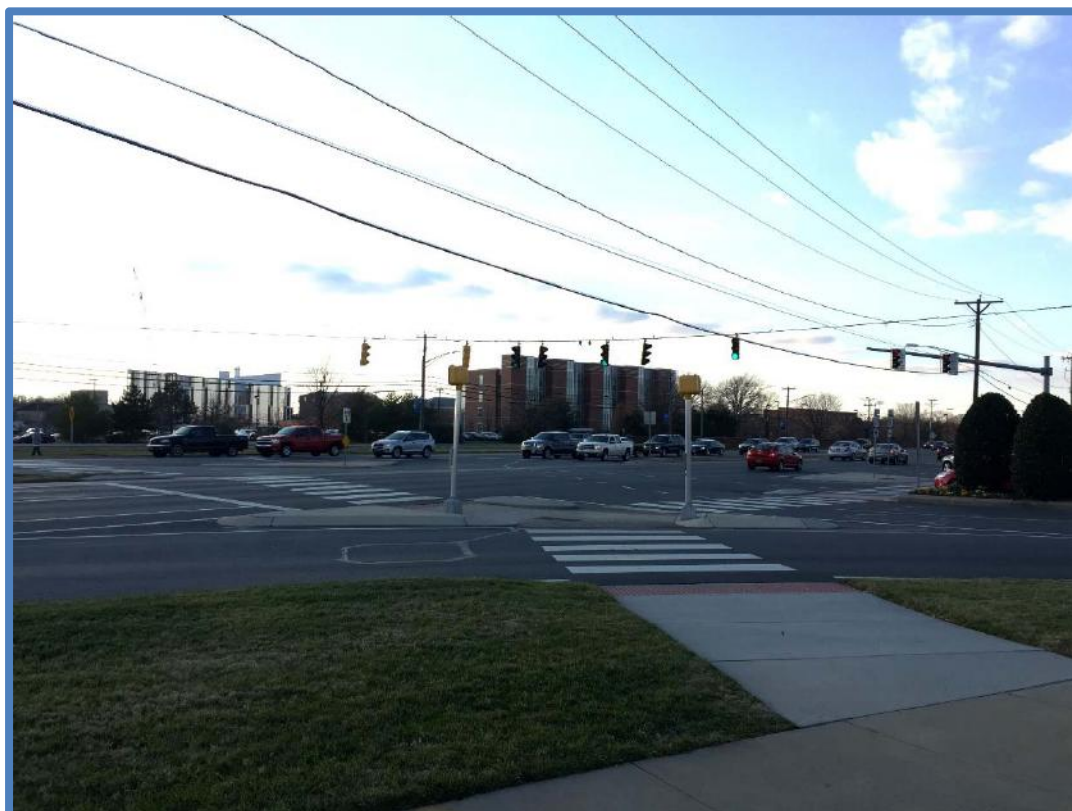
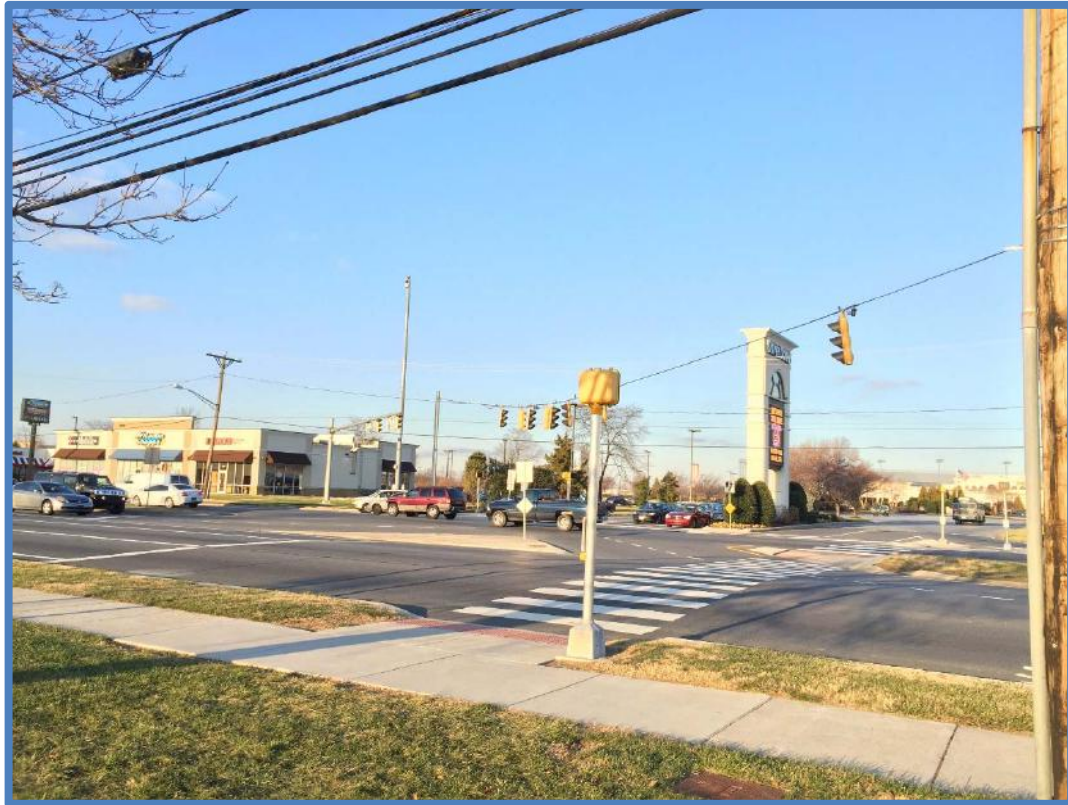
LOCATION 6 – DOVER DOWNS ENTRANCE

Summary: This location is a three legged intersection that has comparatively low pedestrian volumes but a high number that cross. It appears that the pedestrian were crossing to go to the restaurants (Boston Market, Chipotle, Grottos) on the east side of US 13. A large number of pedestrians walked from the parking lot on DSU's campus and crossed immediately at the end of the brick wall. This is very similar to the pedestrian patterns observed with the 2013 counts. The number of pedestrians was less than the previous year.

Concerns: There is significant pedestrian traffic coming from the DSU campus and parking lot which crosses US 13 where the brick wall ends. Since the higher mid-block crossings occurred during the weekday counts it is assumed that this activity happens when classes are in session. This would result in a large number of crossings that don't occur at a crosswalk.

East side of US13 looking south towards Dover

East side of US13 looking west towards DSU

West side of US13 looking East towards Dover Downs

Recommendation: The primary recommendation will be to extend the existing wall to at least the signalized intersection, possibly down to College Road, to create a permanent barrier between the campus and the mid-block crossing. Secondary recommendation would be to continue the landscaping or post and chain fence along the frontage of the DSU campus and along the east side of US 13 to discourage the people on the sidewalk from trying to cross mid-block.
