The Dover/Kent County Metropolitan Planning Organization

Delaware State University Pedestrian Counts

SUMMARY REPORT December 2014

Century Engineering, Inc.
4134 N. DuPont Highway, Dover, DE 19901

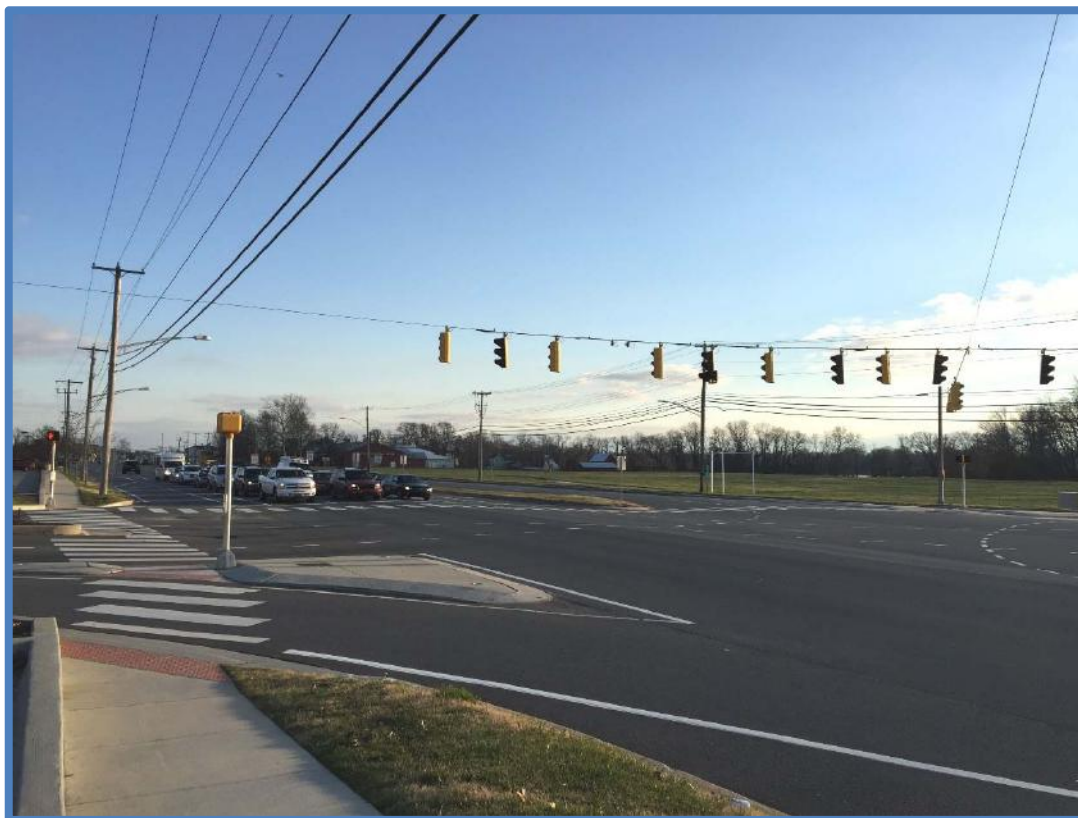
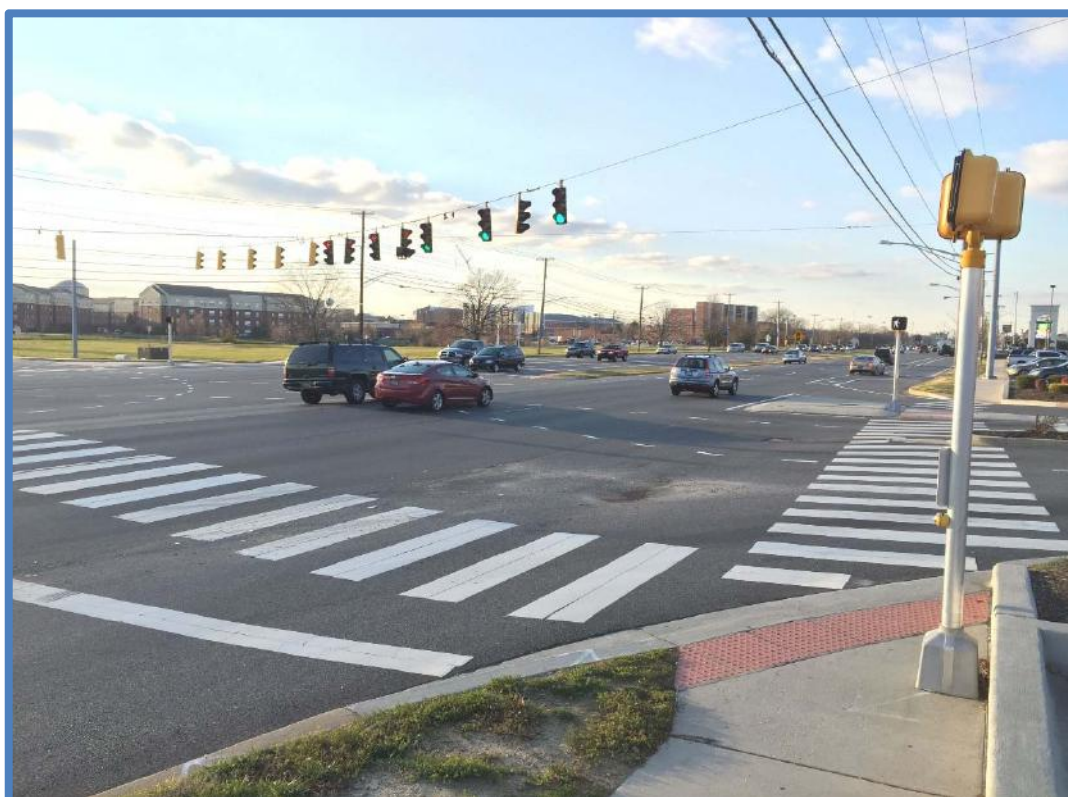
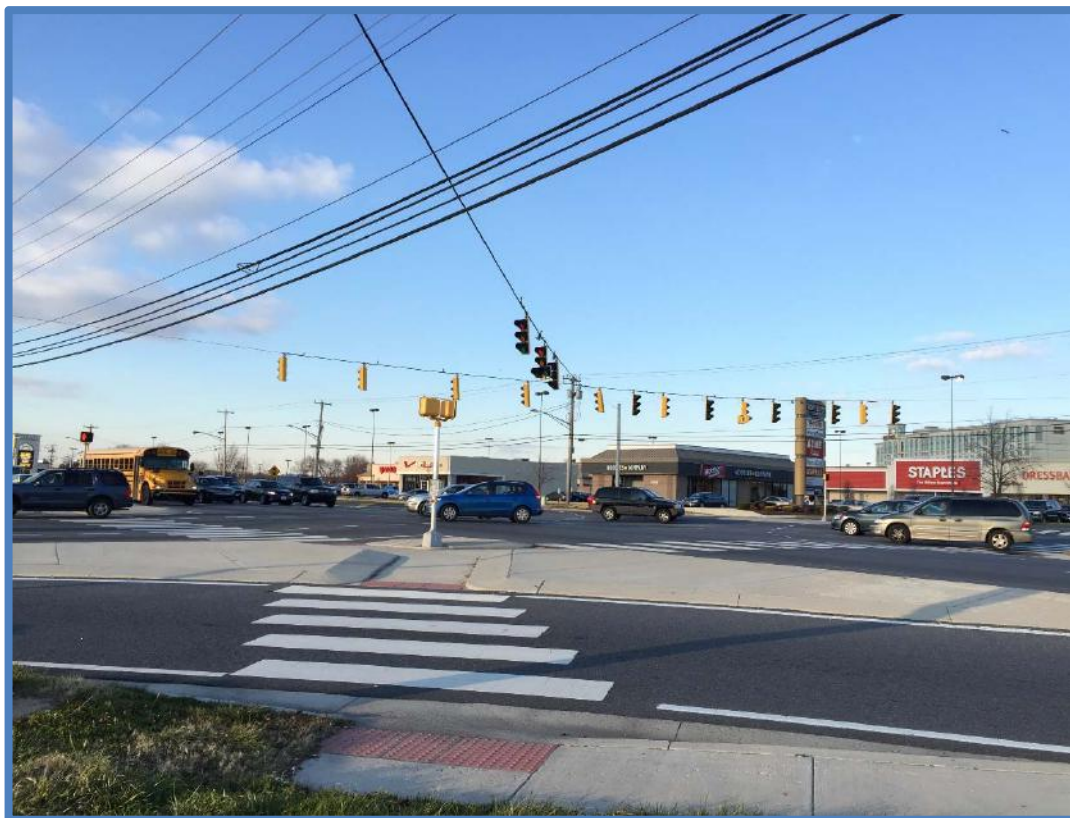
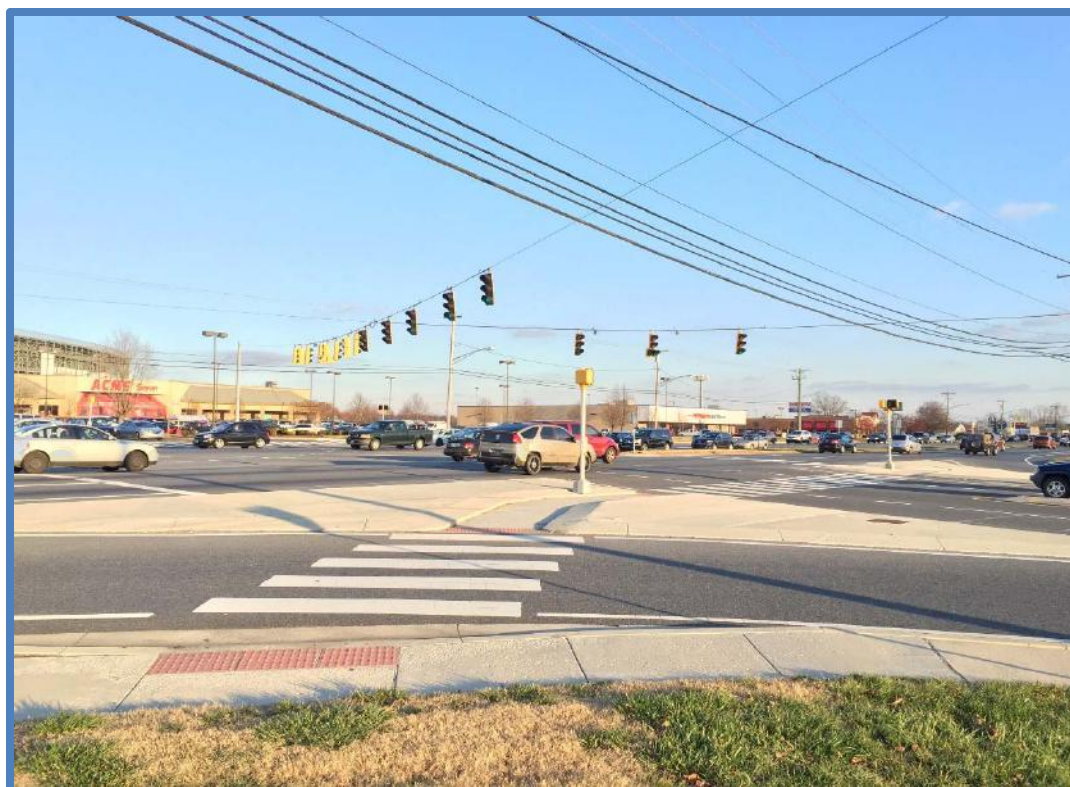
LOCATION 7 – COLLEGE ROAD/US 13

Summary: The Acme shopping center makes the fourth leg of this intersection. The crosswalks were well used but there were still a number of midblock crossings on the northern side of the intersection. The people crossing midblock were going to and from the various stores in the shopping center. The crossing patterns were similar to the 2013 counts but there were more people crossing midblock.

Concerns: The number of people crossing mid-block is too high. The pedestrians were making use of the grass median and gaps in traffic to get to the shopping center.

East side of US13 looking south towards Dover

East side of US13 looking northwest towards DSU

West side of US13 looking east towards Staples

West side of US13 looking southeast towards Acme

Recommendation: The landscaping and physical barriers mentioned in Location 6 could be extended down to College Road to encourage the crossings at the signalized intersections.

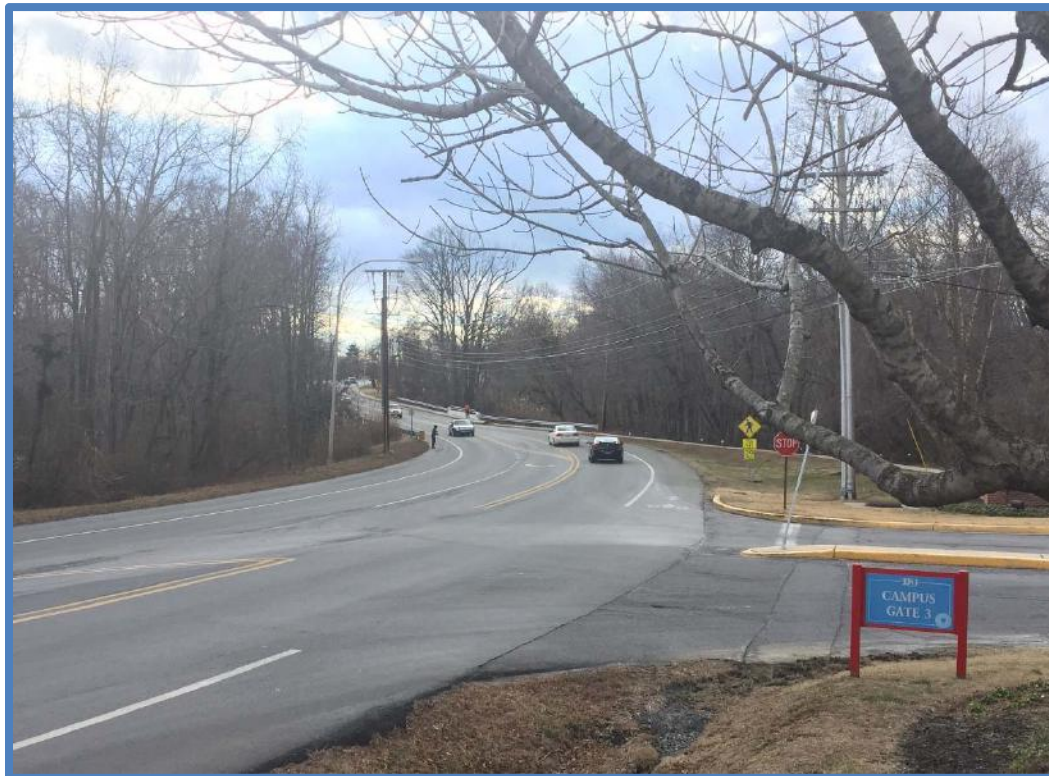
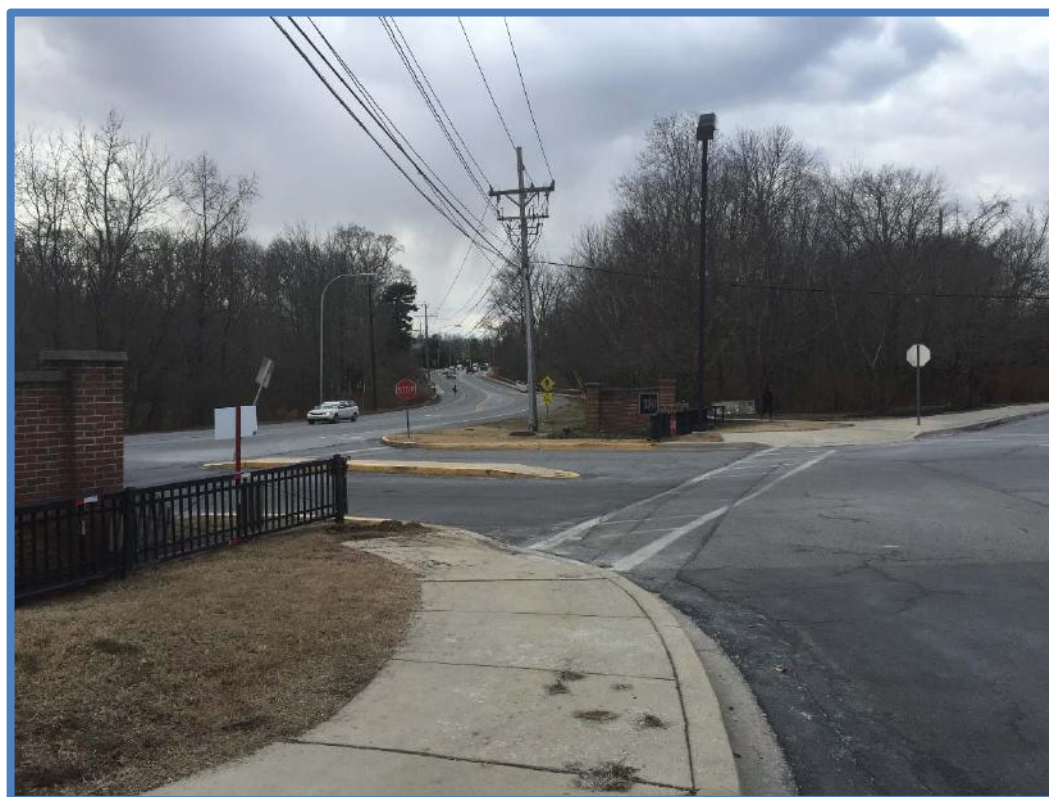
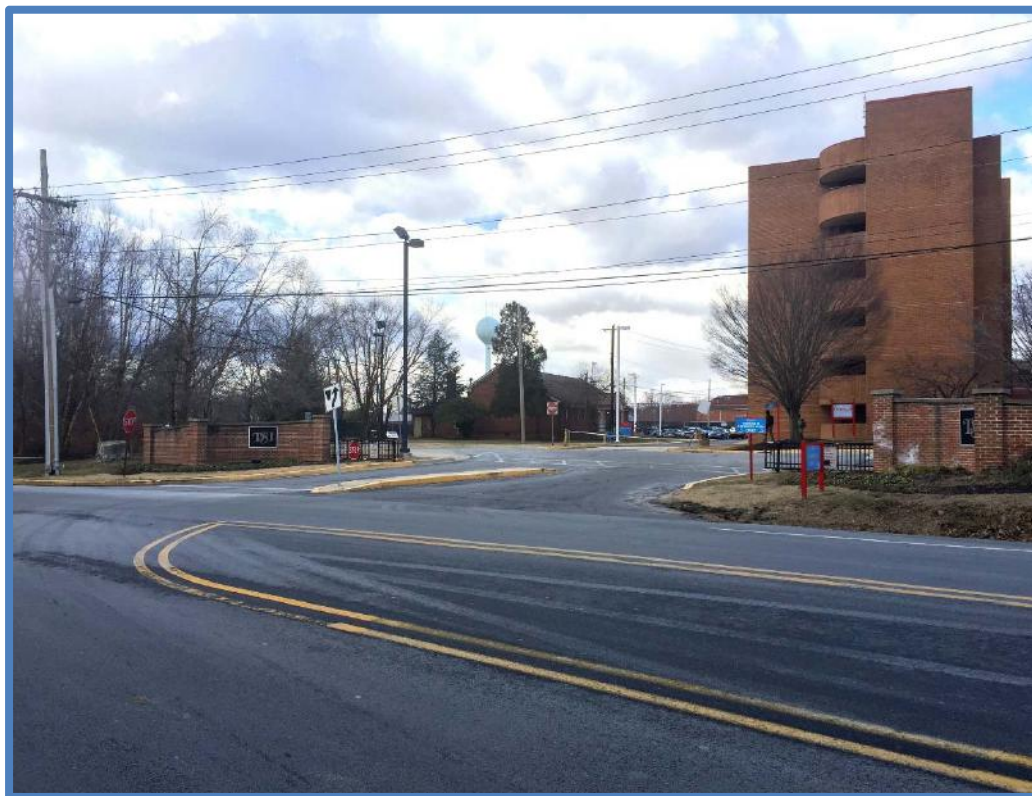
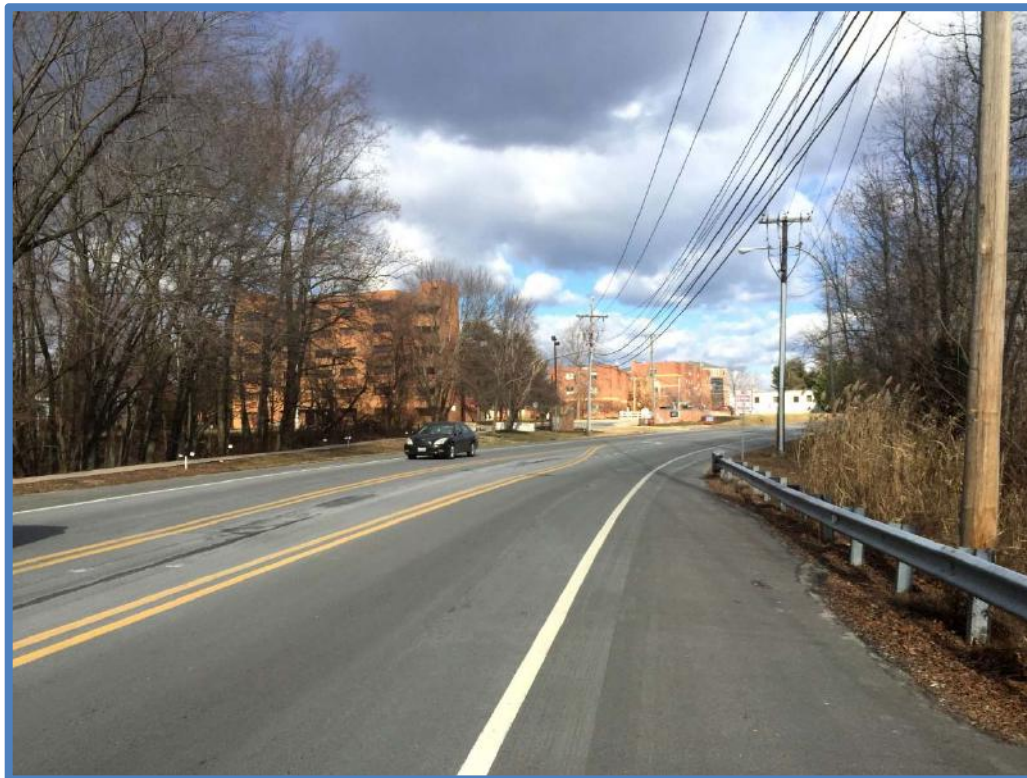
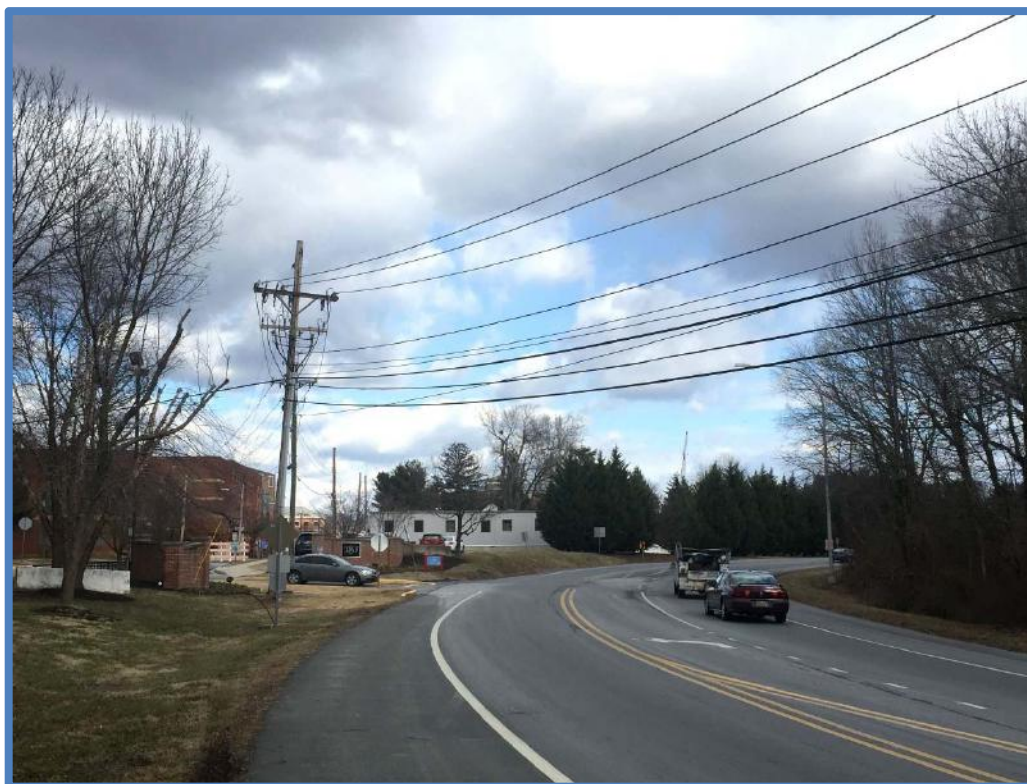
LOCATION 8 – COLLEGE RD AT OLD COLLEGE ROAD

Summary: This was one of the busiest locations in the study. There was significant pedestrian traffic coming from the University Courtyard Apartments on College Road as well as large volumes of pedestrians within Old College Road to get to the facilities on DSU's campus. Very few people were observed crossing at the intersection at College Road since the existing sidewalk ties into Old College Road before the intersection. There is no sidewalk on the south side of the road, east of the bridge, but there were a high number that crossed mid-block between the bridge and west of the intersection. There was also numerous pedestrians who would walk along the shoulder of College Road after crossing the bridge before they accessed the sidewalk. The pedestrian patterns are very similar to those in 2013.

Concerns: College Road is on a curve as it approaches the intersection resulting in poor sight lines to pedestrians who are crossing the street. This is further compounded by the appearance the vehicles are traveling faster than the posted speed limit (35MPH). Even with these conditions there were still a high volume of pedestrians crossing mid-block.

DSU's entrance at Old College Rd looking west on College Rd

DSU's entrance at Old College Rd looking west towards College Rd

DSU's entrance at Old College Rd looking northwest towards entrance

Looking east on College Rd towards DSU's entrance at Old College Rd.

Recommendation: As in 2013, this location and location 10 should have additional study to determine the most effective way to improve the safety for pedestrians crossing College Road. Due to limited space where the sidewalk runs along the roadway/bridge, options for physical barriers are limited but items such as a post and chain fence may still be feasible. Other options could include reviewing the pathways at the apartments to see if they can be modified to direct pedestrians to the crosswalk, construction of a larger sidewalk on the north side of College Road to accommodate the number of users. Signage and education to encourage pedestrians to cross at designated locations should be encouraged. This may be a location where enforcement of both pedestrian and vehicle activity should be considered to reduce vehicle speeds and direct pedestrian crossings at the appropriate locations. A speed study may also be performed to determine if the speed limit is appropriate for the roadway.

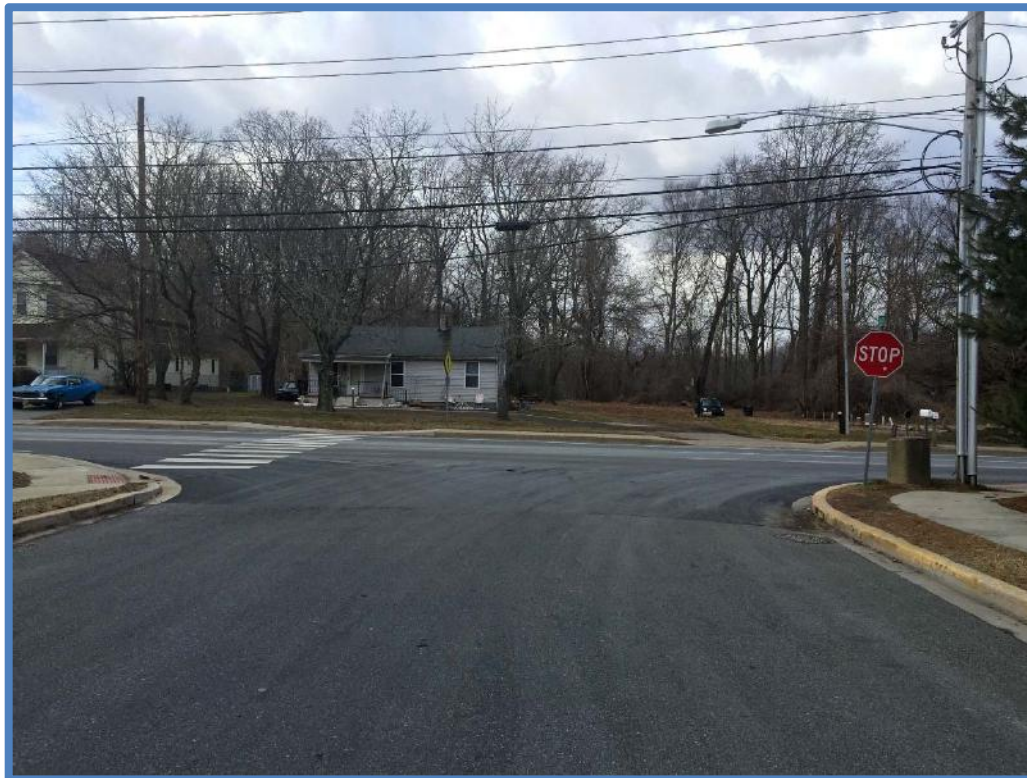
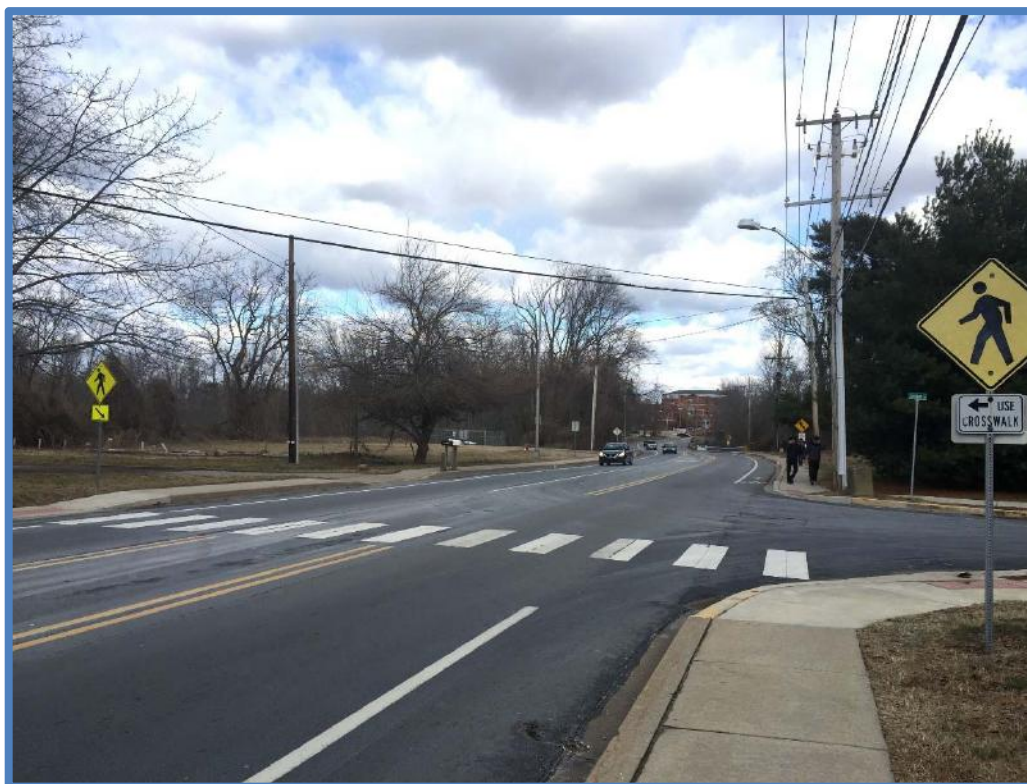
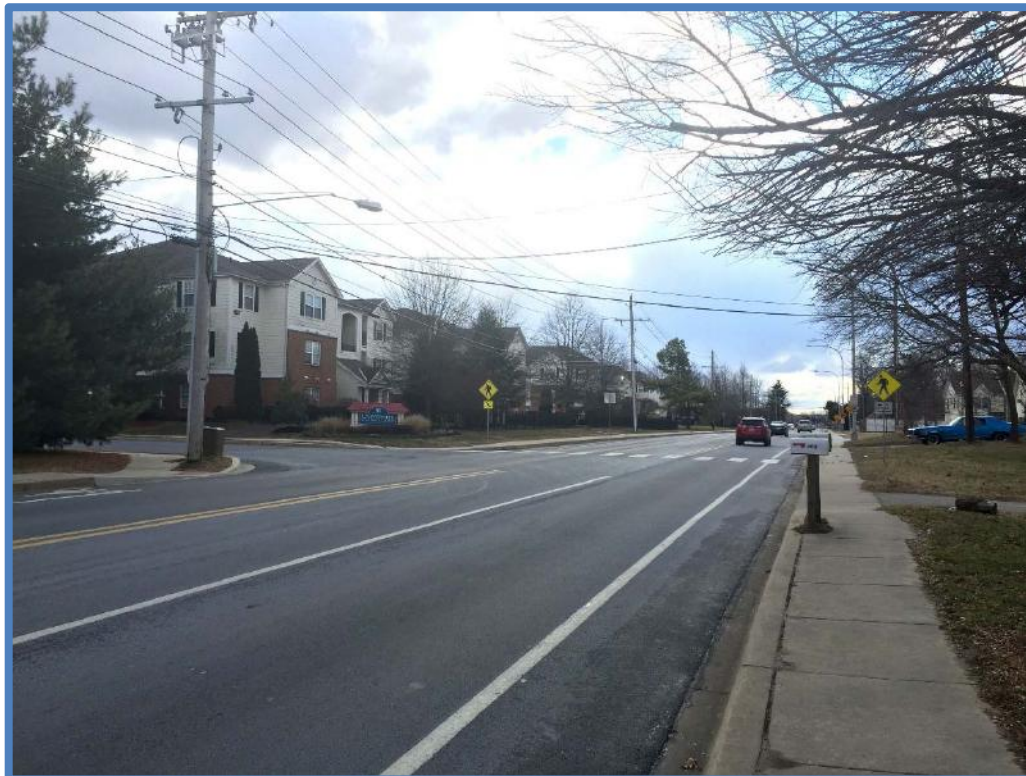
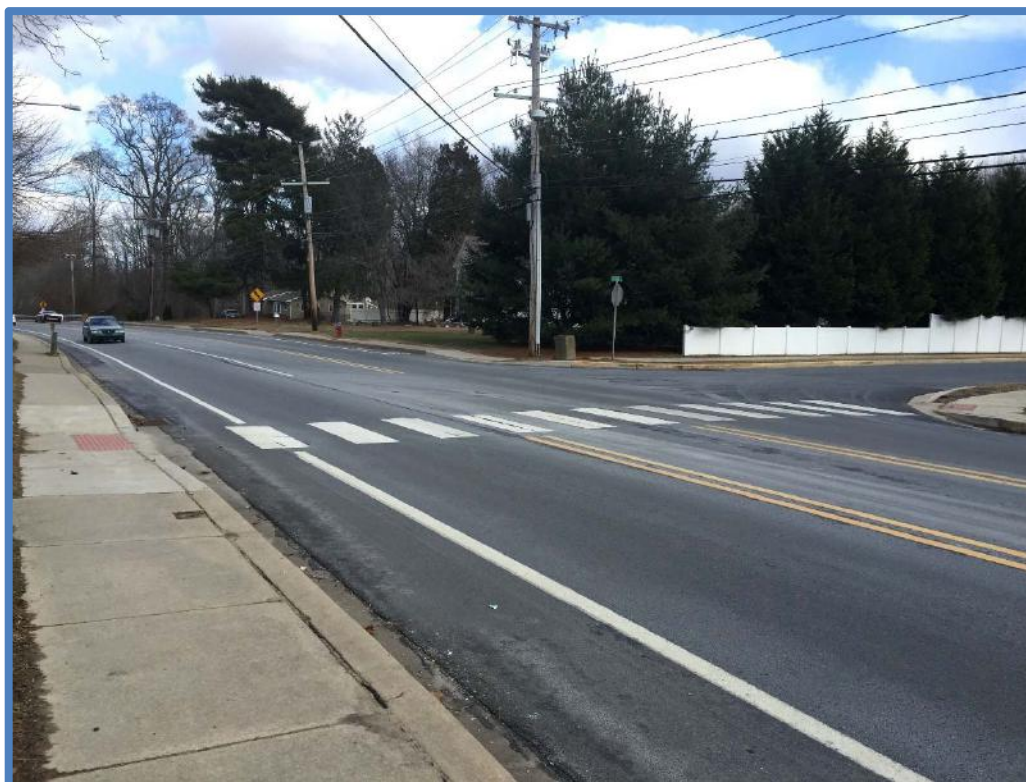
LOCATION 9 – JASON COURT

Summary: As in 2013, this location had the largest pedestrian volumes during the weekday count which is consistent with its proximity to the University Courtyard Apartments. There was significant pedestrian traffic going to/from the University Courtyard Apartments traveling toward DSU's campus but very few people used the marked crosswalk on College Road. There is existing sidewalk on both sides of the road between the entrance and the bridge. The pedestrian patterns are very similar to those of 2013.

Concerns: As with the previous location, the curvature of College Road reduces sight distance and vehicles appear to travel faster than the posted speed limit (35MPH). Even with these conditions an extremely high volume of pedestrians crossed mid-block. Many of the pedestrians who cross the road are distracted by their phones or friends making for an even more dangerous condition.

University Courtyard Apartments looking north toward College Rd

University Courtyard Apartments looking east on College Rd

University Courtyard Apartments looking west on College Rd

Recommendation: Due to the large number of pedestrians this location should be considered for additional crossing features such as warning signs, reduced crosswalk width or High-Intensity Activated crosswalk beacons. The location of the crosswalk should be reviewed to see if it would be more appropriate on the east leg of the intersection since that is closer to the destination. Signage and education to encourage pedestrians to cross at designated locations should be encouraged. Enforcement of both pedestrian and vehicle activity should also be considered to reduce vehicle speeds and direct crossings at the appropriate locations.
