Cheswold US13 Pedestrian Safety and Connectivity Study

February 2024

Summary of Findings

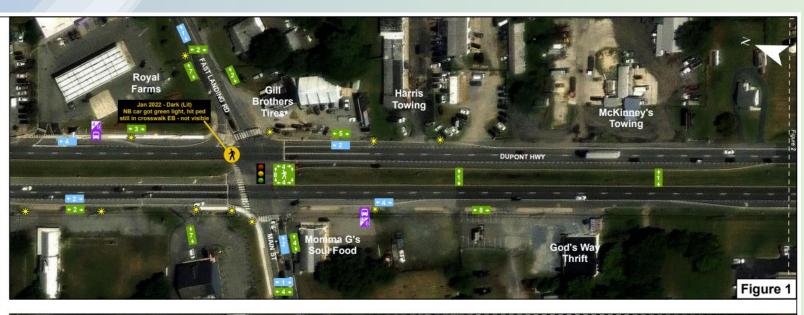
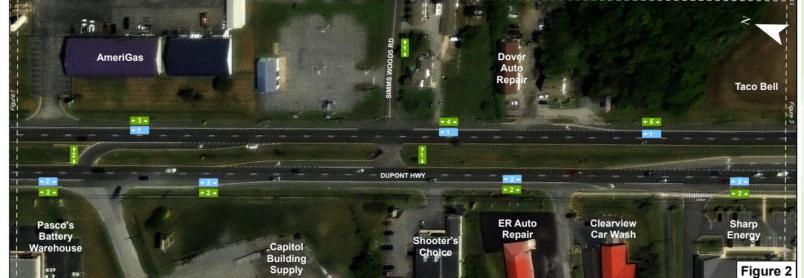
Existing Conditions

US 13

Cheswold DE:

North of Main St to Rose Bowl Rd

Traffic Signal

Existing Luminaire

Daily Bus Board/Alight

Total Ped Volume (6 hours, AM/MID/PM Peaks)

Total Bicycle Volume (6 hours, AM/MID/PM Peaks)

Non-Injury Crash

Pedestrian Injury Crash

Fatal Crash Pedestrian Non-Injury Crash

Bicycle Fatal Crash

Injury Crash

Nighttime Crash

Crash study period - January 2014

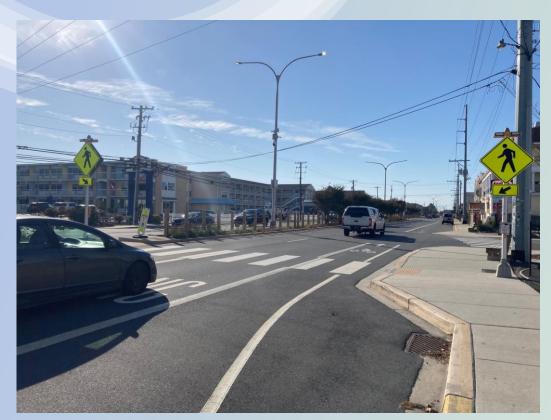
Rapid Flash Beacon (RFB) and midblock crossing (Example from Dewey Beach)

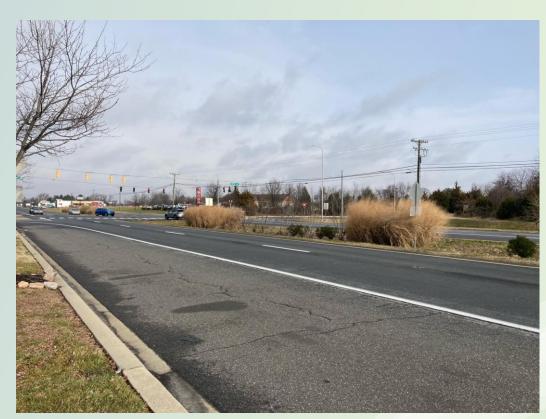
Median with plantings to help calm traffic (Example from Smyrna)
