Re: South Dover Elementary School Traffic Circulation and Safety Assessment Technical

Memorandum

The Dover/Kent County MPO contacted Rossi Group to conduct a traffic circulation and safety assessment of the South Dover Elementary School campus and South State Street approaches north and south of the campus entrance. The assessment is being funded by DelDOT's Division of Planning. The Capital School District and City of Dover are also stakeholders in the assessment.

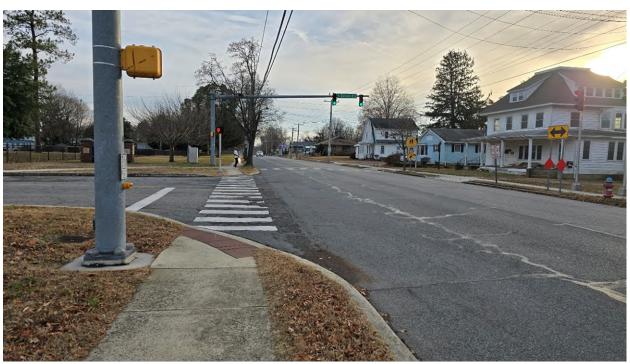
The intersection of South State Street and the South Dover Elementary School entrance is a signalized three-legged intersection, shown in **Figure 2**. Marked crosswalks with pedestrian signals and push buttons exist on the south and east legs, with the pedestrian signal on the south leg crossing having a separate phase.

At the intersection, the following lane configurations exist:

- School entrance/exit consists of one entrance lane and one exit lane; the exit lane has two separate turn lanes, one left and one right;
- South State Street northbound approach consists of one shared through-right lane;

• South State Street southbound approach has one shared through-left lane, respectively.

Figure 2: Intersection of South State Street and South Dover Elementary School entrance looking south

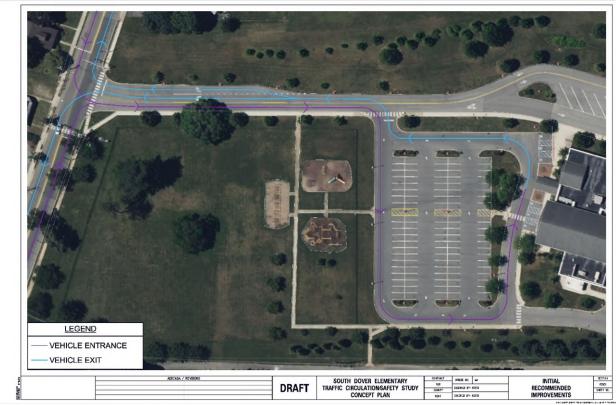
All other incoming traffic must turn right into the school parking lot. The parking lot entrance is the south leg of the internal intersection with the school driveway, west of the bus loop. The main entrance of the school is off of the parking lot, and the drive aisle utilized for student drop-off and pick-up. Pavement marking arrows and 'Do Not Enter' signage indicate the direction of traffic flow within the parking lot as oneway counterclockwise. In the field, orange traffic barrels were observed being used to prevent vehicles from entering the wrong way in the parking lot and the bus loop (Figure 3). Figure 4 shows the circulation pattern of vehicles arriving for student drop-off and pick-up.

Figure 4: Internal circulation for student drop-off and pick-up

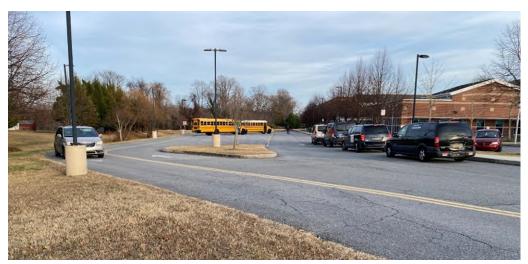
During the drop-off period, buses were first observed arriving at the school between 8:15 a.m. until 8:40 a.m. and departing from 8:40 a.m. until about 8:50 a.m. (Figure 8) Vans arrived during the drop-off period between 8:05 a.m. and 8:40 a.m. All vans left the campus by about 8:43 a.m. During the pick-up period, buses arrived between 3:07 p.m. and 3:40 p.m., and departed between 3:30 p.m. and 3:49 p.m.

Figure 8: Bus loop during evening pick-up

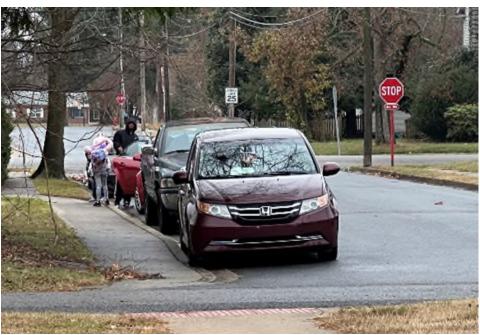
During meetings with the City and school officials, drop-off and pick-up traffic was noted as a concern in the alley adjacent to the school and parallel to Pine Street (Figure 10). In the field, Rossi staff observed the alley and saw instances of vehicles parking on the neighborhood streets adjacent to the school, and in the alley, to walk their children to the school. Not many of these cases were observed in the field, and parking on streets to walk children to school is legal.

Figure 10: Vehicle parked on Park Avenue to drop-off children

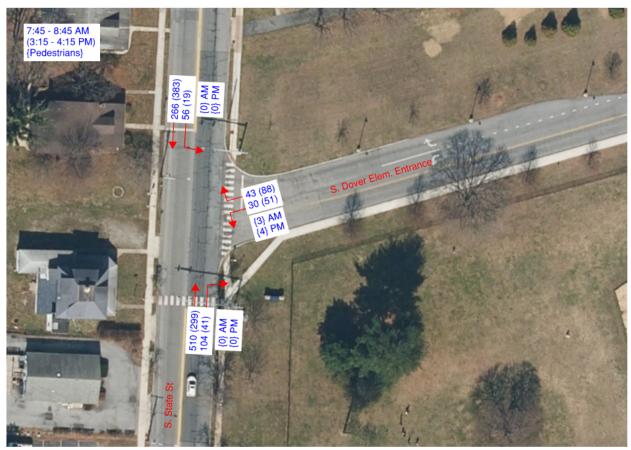
Traffic and pedestrian counts were performed on Tuesday, November 19, 2024, between 7:30 a.m. and 9:30 a.m. and between 2:30 p.m. and 4:30 p.m. The morning and afternoon peak hour counts representing the drop-off and pick-up periods, respectively, are between 7:45 a.m. and 8:45 a.m. and between 3:15 p.m. and 4:15 p.m. and shown in **Figure 11**. The morning drop-off had higher traffic volumes on northbound South State Street and turning into the school entrance than the afternoon pick-up. However, afternoon pick-up had higher traffic volumes on southbound State Street and westbound from the school entrance, exiting the school. Northbound South State Street had higher volumes turning into the school entrance than southbound South State Street in the morning and afternoon peak hours. There was very low pedestrian volume during the morning and evening peak hours, with pedestrian volume only present crossing the State Street.

Figure 11: AM and PM Peak Hour Volumes at South State Street and South Dover Elementary School Intersection

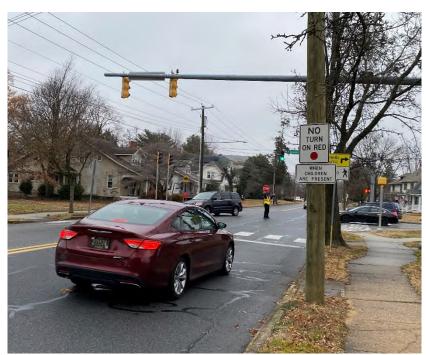
Figure 12: Constable directing traffic at South State Street intersection

The Manual on Uniform Traffic Control Devices (MUTCD) has standards on crossing guard uniform and operating procedures. The following guidance from the MUTCD should be followed for any staff directing traffic or assisting with street crossing:

- Law enforcement officers performing school crossing supervision and adult crossing guards shall wear highvisibility retroreflective safety apparel labeled as ANSI 107-2004 standard performance for Class 2.

- Adult crossing guards shall not direct traffic in the usual law enforcement regulatory sense. In the control of traffic, they shall pick opportune times to create a sufficient gap in the traffic flow. At these times, they shall stand in the roadway to indicate that pedestrians are about to use or are using the crosswalk, and that all vehicular traffic must stop.

- Adult crossing guards shall use a STOP paddle. The STOP paddle shall be the primary hand-signaling device.
- The STOP (R1-1) paddle shall be an octagonal shape. The background of the STOP face shall be red with at least 6-inch series upper-case white letters and border. The paddle shall be at least 18 inches in size and have the word message STOP on both sides. The paddle shall be retroreflectorized or illuminated when used during hours of darkness.

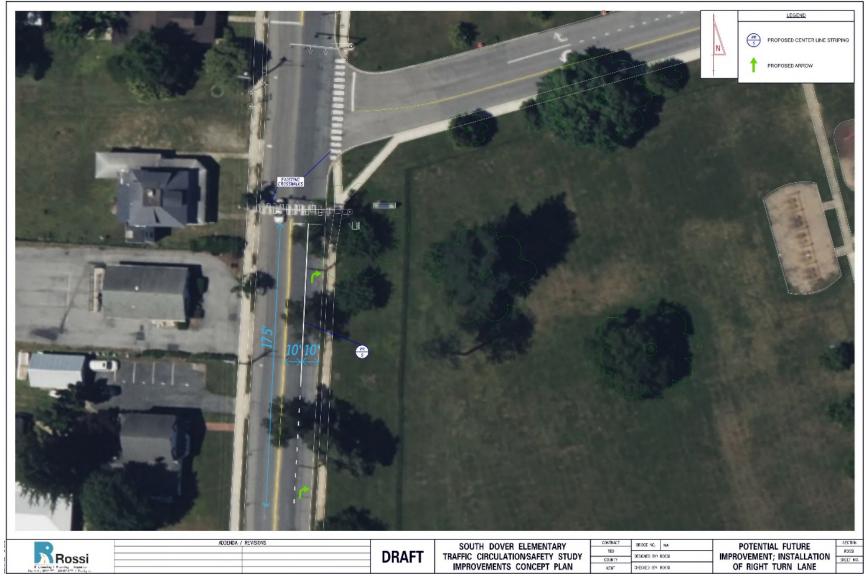
Figure 14: Recommendation B: Installation of Right-Turn Lane at South State Street Intersection

If Recommendation A is implemented and queuing remains an issue on South State Street, the installation of a right-turn lane on the northbound approach of South State Street, as shown in **Figure 14**, is recommended to reduce lane confusion by separating the through traffic from those waiting to turn into the school. The queueing onto South State Street during school drop-off and pick-up periods blocks through traffic or causes vehicles to bypass the right-turn queue without a designated second lane and encroach over the centerline. The current northbound lane is 20 feet wide, which provides space for two 10-foot lanes. Due to the existing and proposed lane widths the centerline striping would not be impacted. The speed limit in the area is 25 mph and 20 mph when students are present in the school zone. Ten-foot lanes are appropriate with low speed limits located within city limits. The right-turn lane is proposed to be striped for 175-foot in length to provide capacity of seven vehicles with right-turn arrow markings.

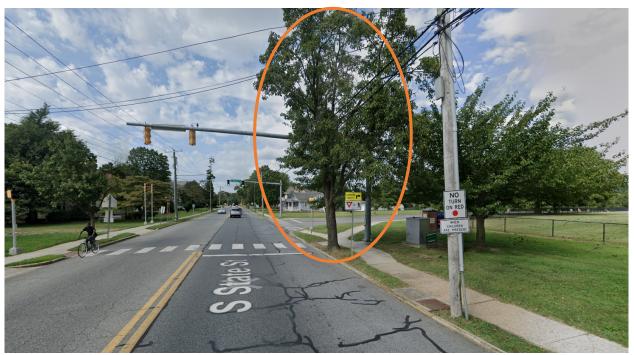
Figure 16: Tree Recommended for Relocation on South State Street

One tree on the corner of the South State Street and school entrance intersection (shown in **Figure 16**) is recommended to be removed to improve the line of sight. The tree is located in the grass buffer between the roadway and sidewalk, adjacent to the northbound stop bar at the school intersection, just in front of the ramp to the crosswalk on South State Street. For northbound vehicles, this tree is an obstruction to the line of sight of pedestrians waiting to cross South State Street. Removing and replanting a tree on site would improve the safety of the crossing at this intersection by improving the line of sight of pedestrians, which, due to the proximity to the elementary school, are likely to be small children. A new tree could be planted on the school grounds east of the existing tree.

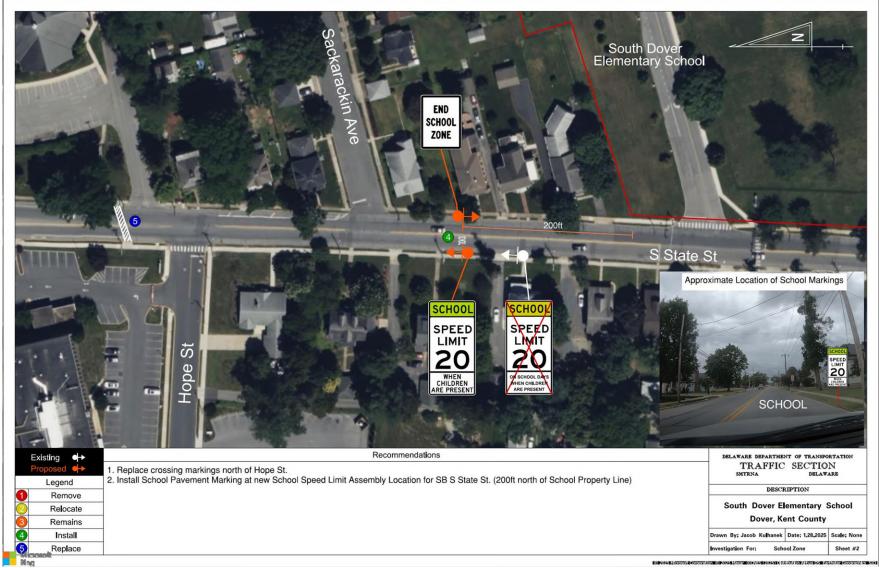
Figure 17: School Zone Marking Recommendations (1 of 2)

The MUTCD has standards on signing and marking required for school zones. Within proximity to Dover Elementary School there is existing school zone signing and marking along South State Street. However, some of these are not compliant with the current MUTCD. The signing and marking recommendations detail the improvements required to make the School Zone compliant with MUTCD standards. **Figures 17-20** are signing and marking recommendations provided by DelDOT.

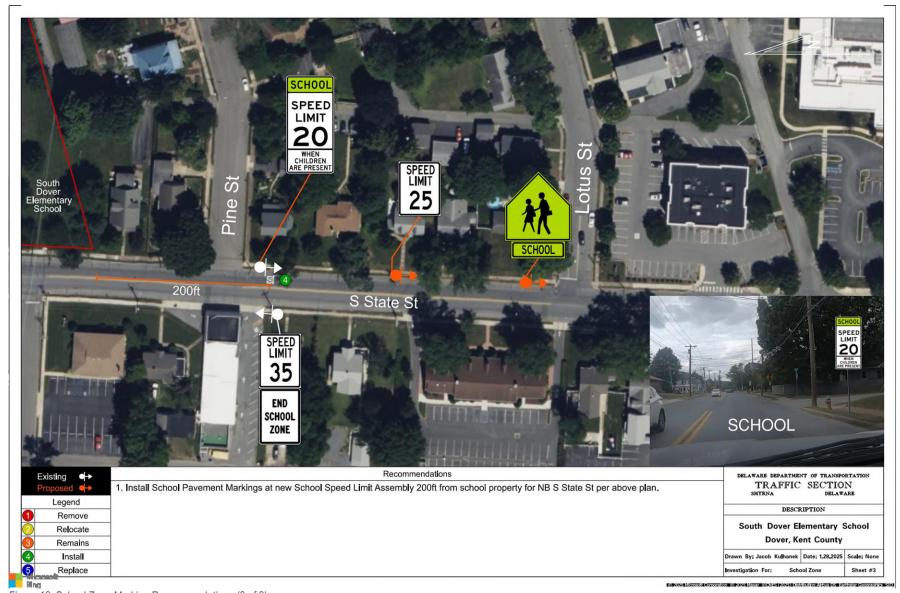
Figure 18: School Zone Marking Recommendations (2 of 2)

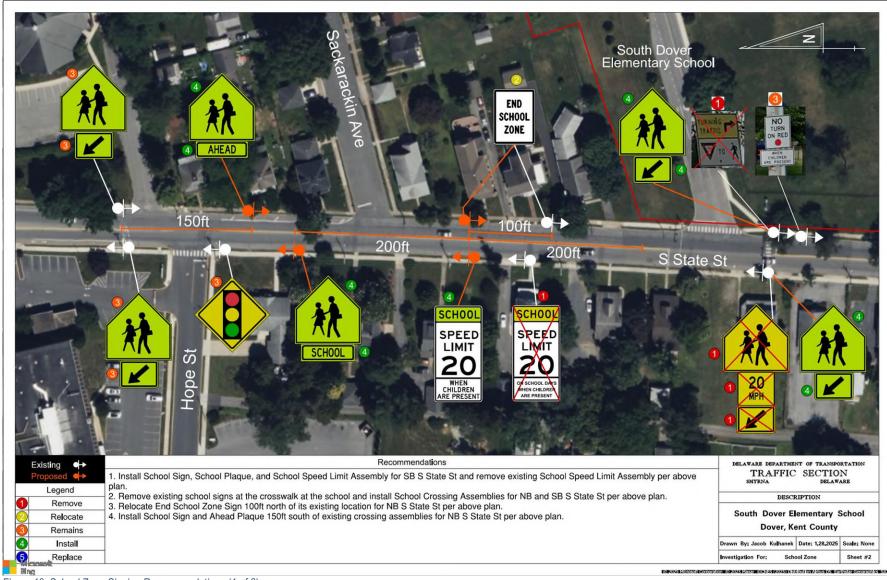
Figure 19: School Zone Signing Recommendations (1 of 2)
